SAN FRANCISCO FIRE DEPARTMENT

**Safety Investigation Report
Line of Duty Deaths
133 Berkeley Way
June 2, 2011
Box 8155
Incident # 11050532**

February 2012

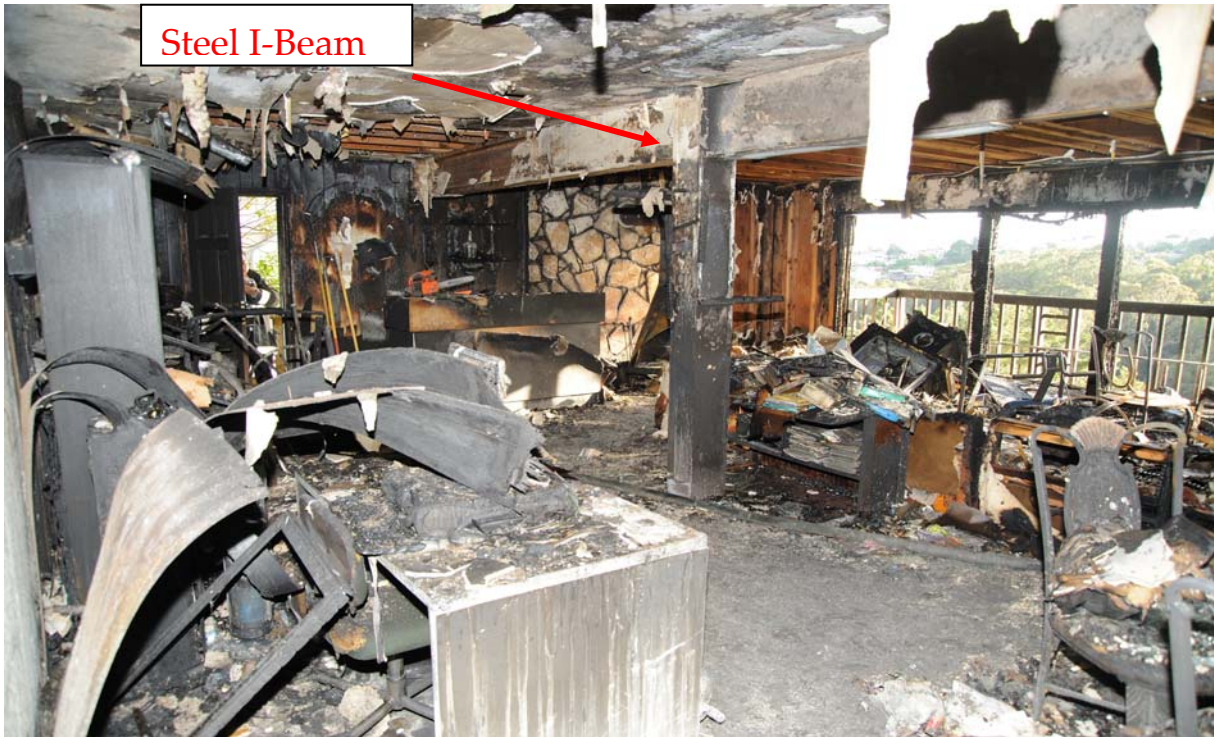
Sublevel 1 (Fire Room) with steel I beam.

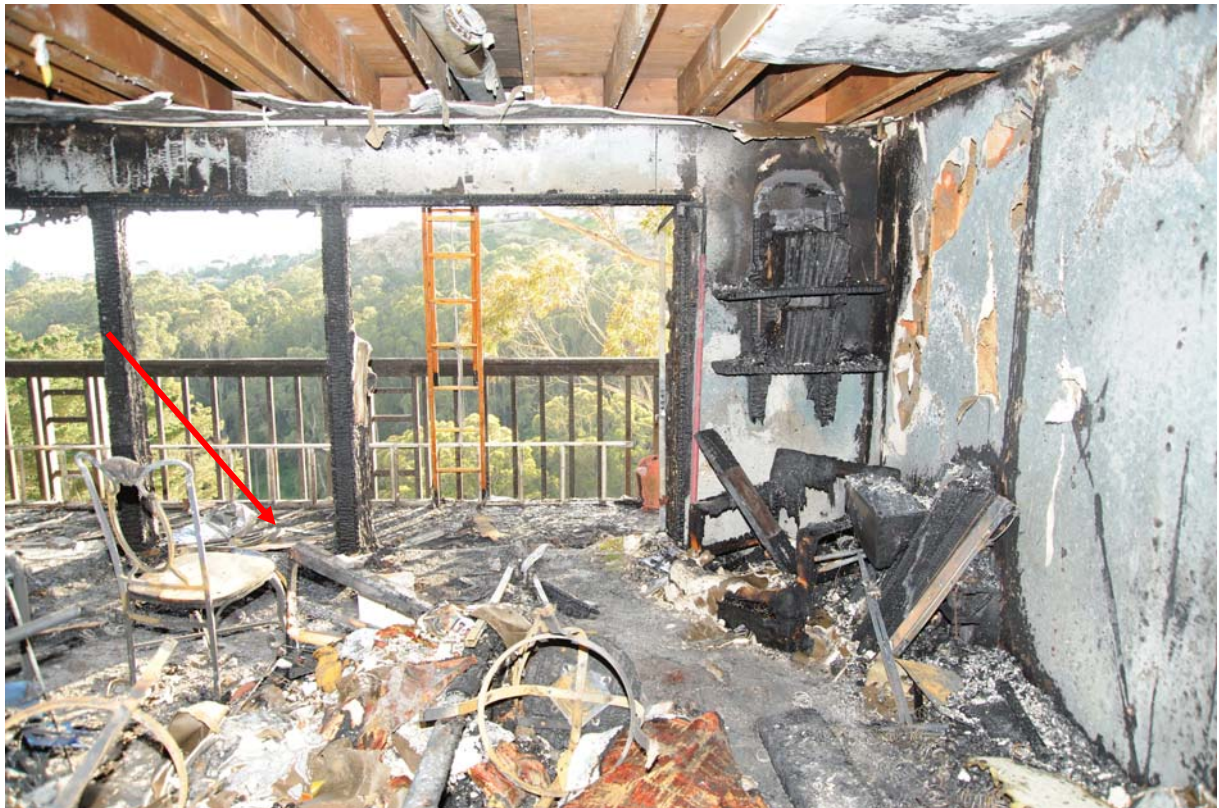
Sublevel 1 (Fire Room) Charlie/Delta corner with arrow on point of origin

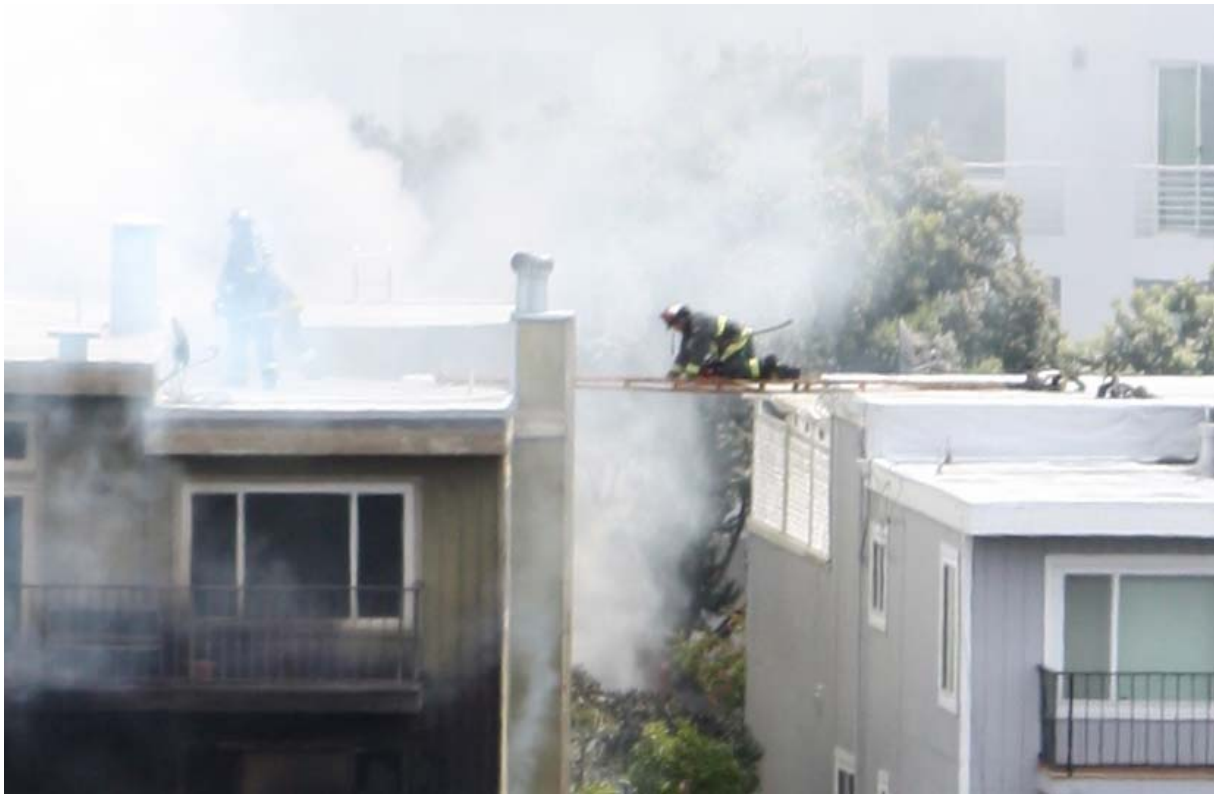
Truck 11 bridging between Bravo and the Fire Building. Bridging is an extremely dangerous maneuver and should only be used in an emergency/life saving situation.

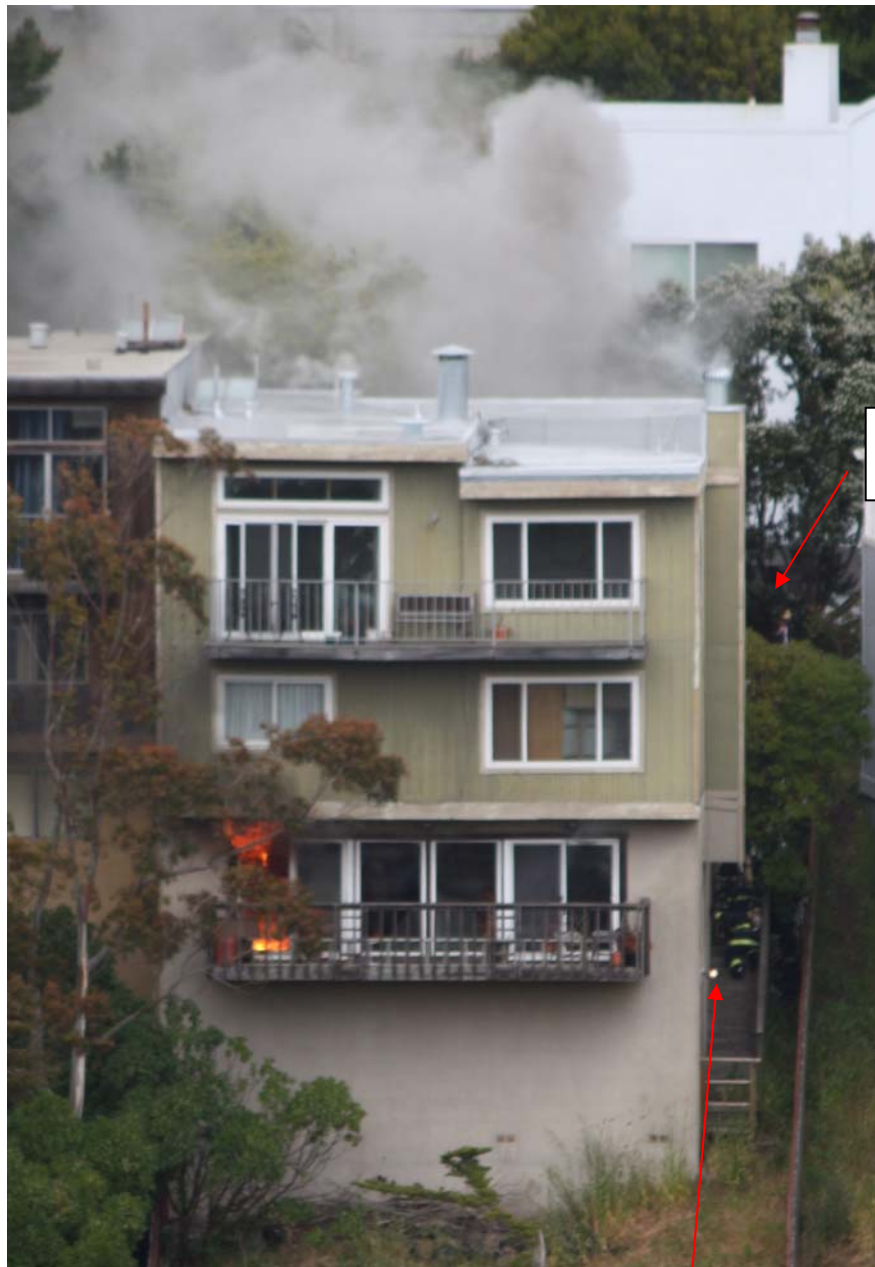
10:58:42 Window in the rear of Charlie Side fails. Battalion 9 and Engine 11 at door of Sublevel 1. Crews have not made entry into Sublevel 1. Note smoke conditions change in the front of the building and IC has moved due to smoke obscuring the Command Post. (6574)

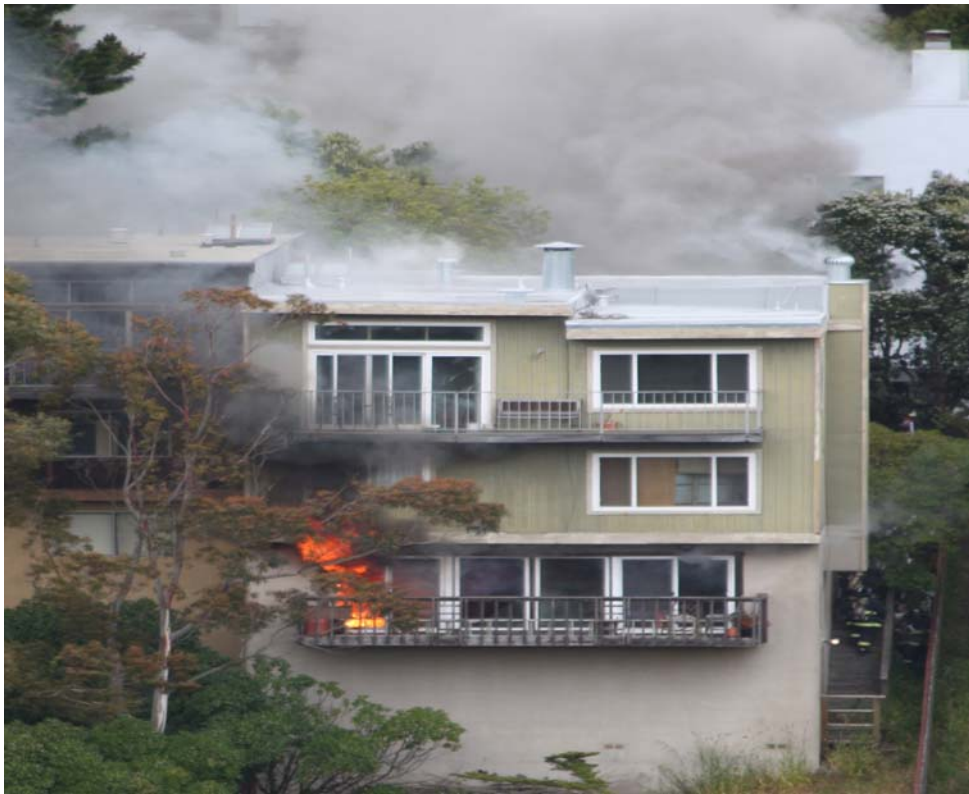
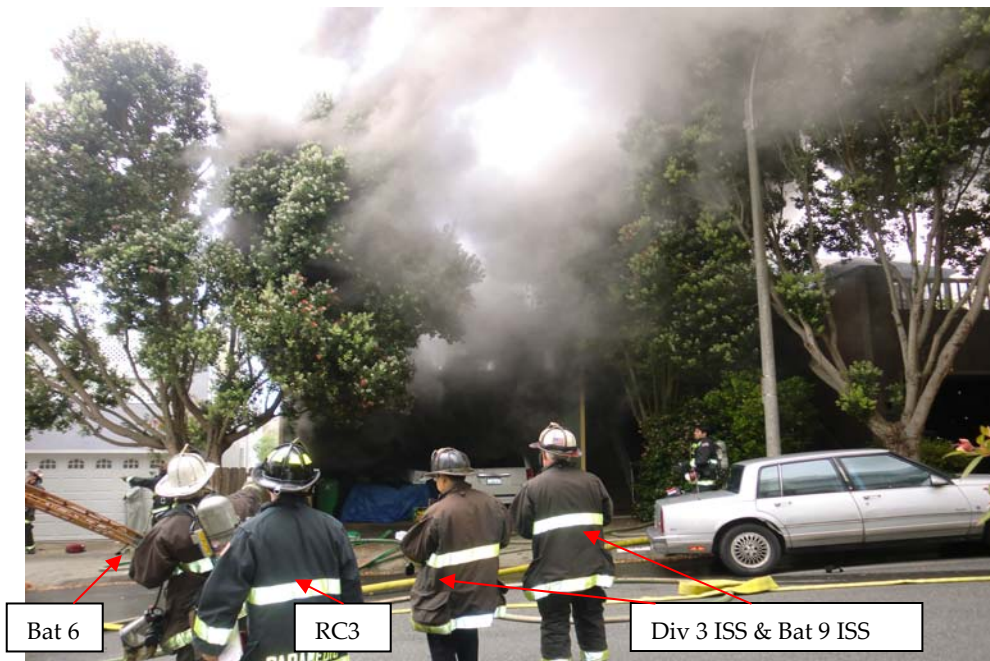
These two pictures were taken one second apart. Top picture shows rapid fire spread in Charlie/Delta corner. Note Engine 11 and Battalion 9 have not yet breached door. Bottom picture shows Battalion 6 conferring with the Incident Commander (not in frame). At this time, Engine 24 and Rescue 1 Team A are inside garage attempting to gain entry through access door from garage. During the post incident interviews, both crews reported that they confronted extreme heat conditions (See Rescue Squad 1 Findings).

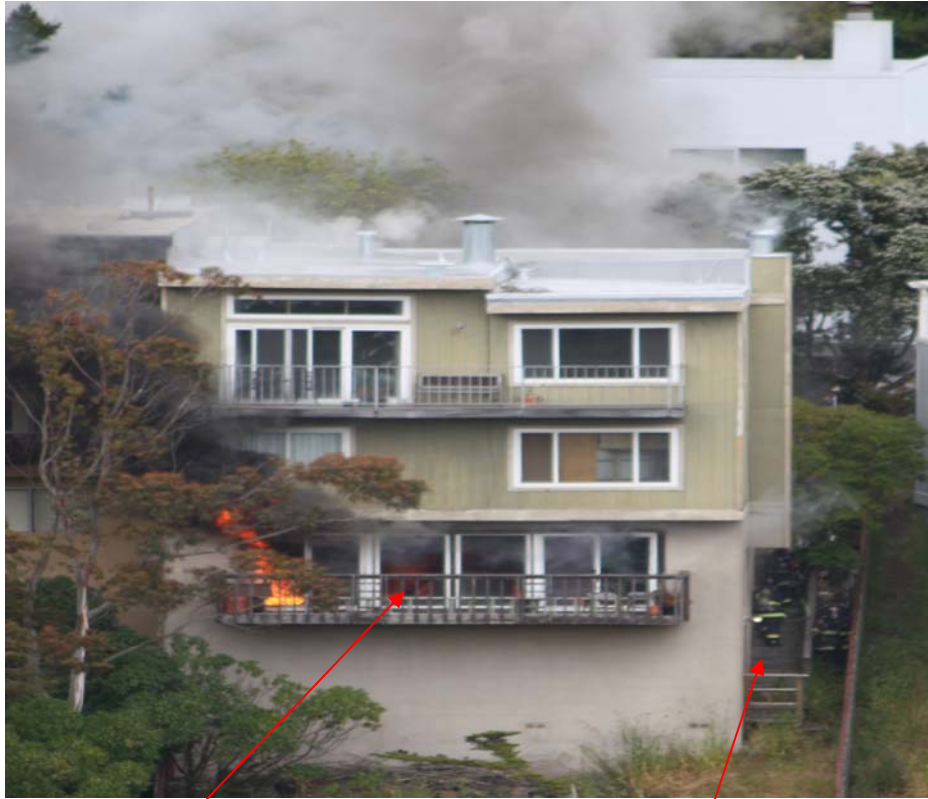
10:58:54 Note fire growth on Sublevel 1. Crews have not yet made entry. (6576)

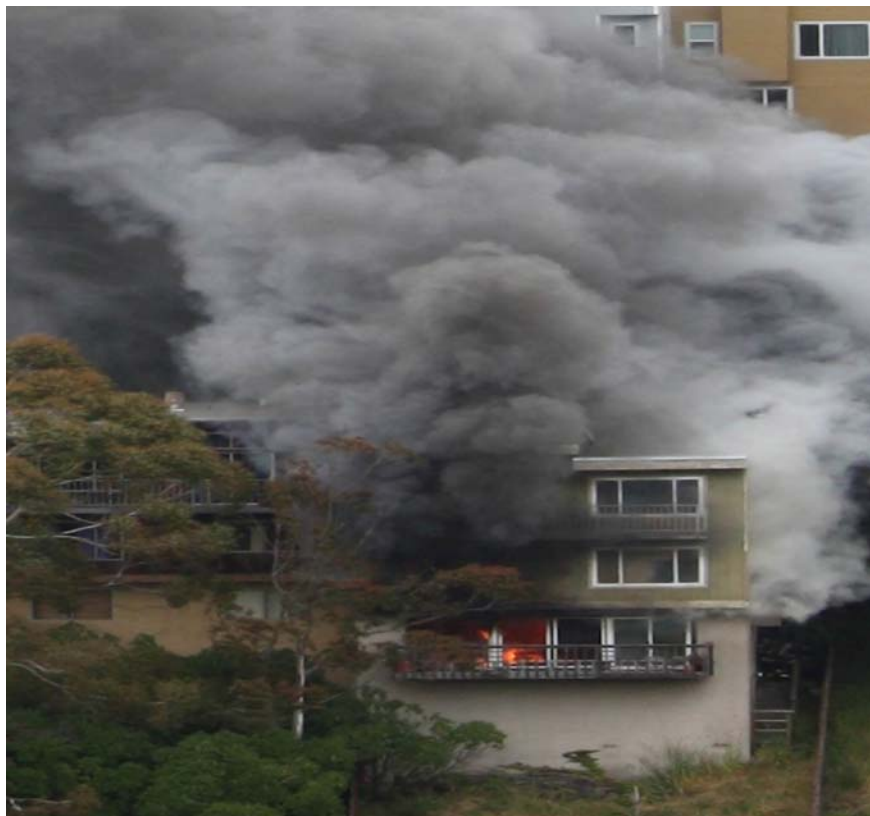
10:59:58 Note second window from the left has failed. Smoke conditions continue to change, due to application of water. (6582)

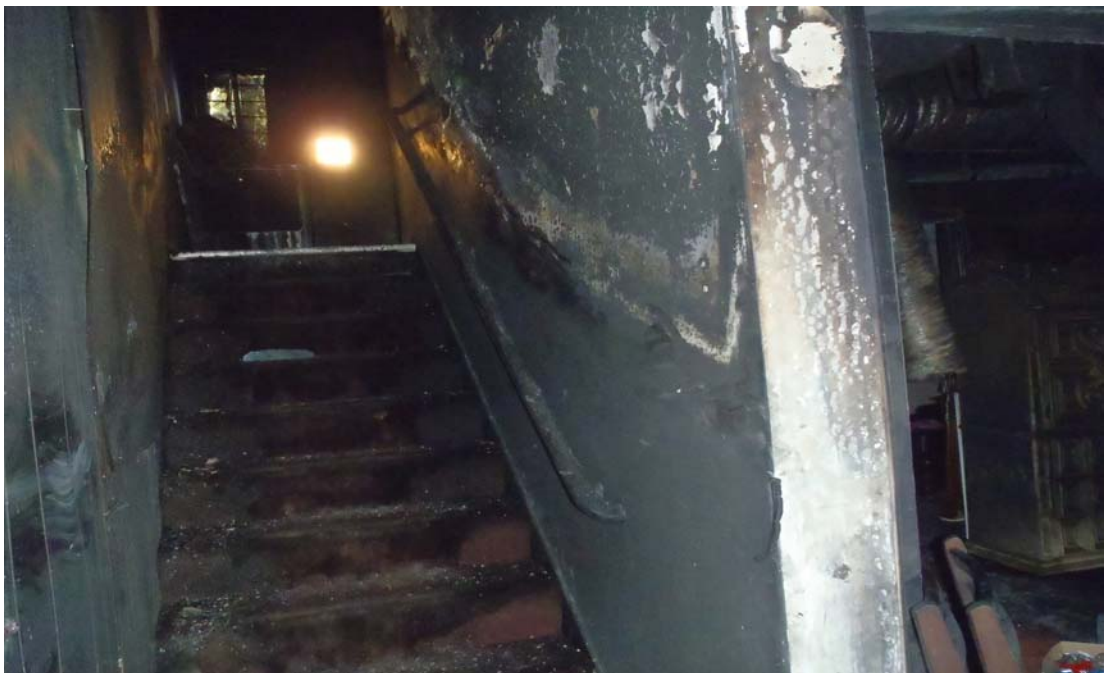
Looking up the stairs from the fire room, note the heat damage on the walls

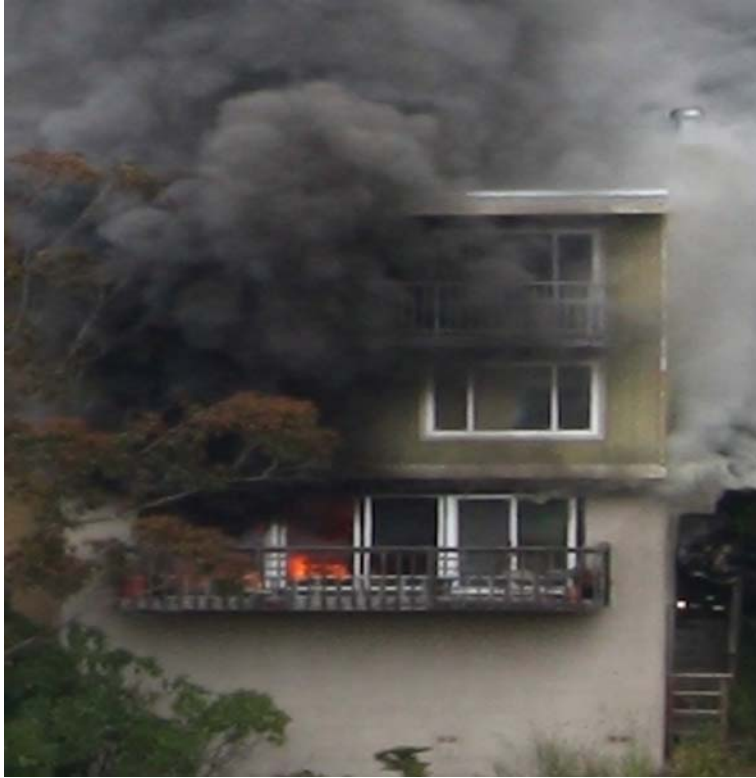
Color of the smoke being generated, indicates a hot and high carbon based fire

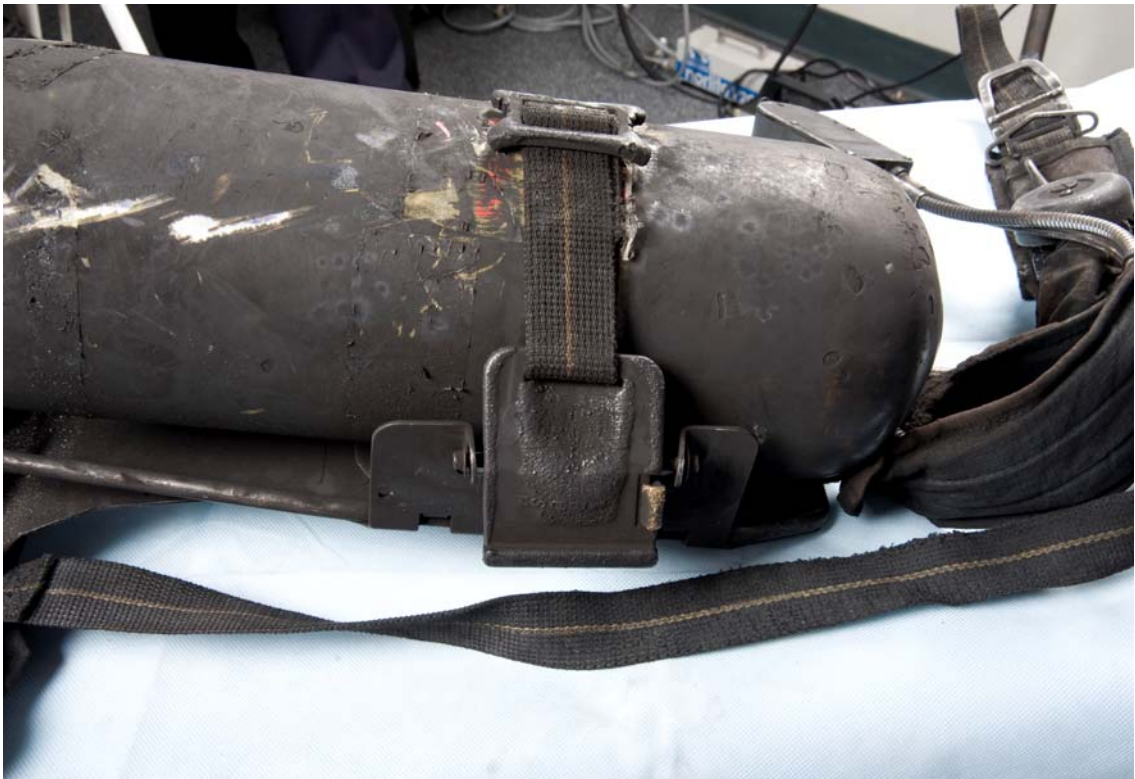
Note amount of carbon material that has been baked onto the SCBA of Victim 1

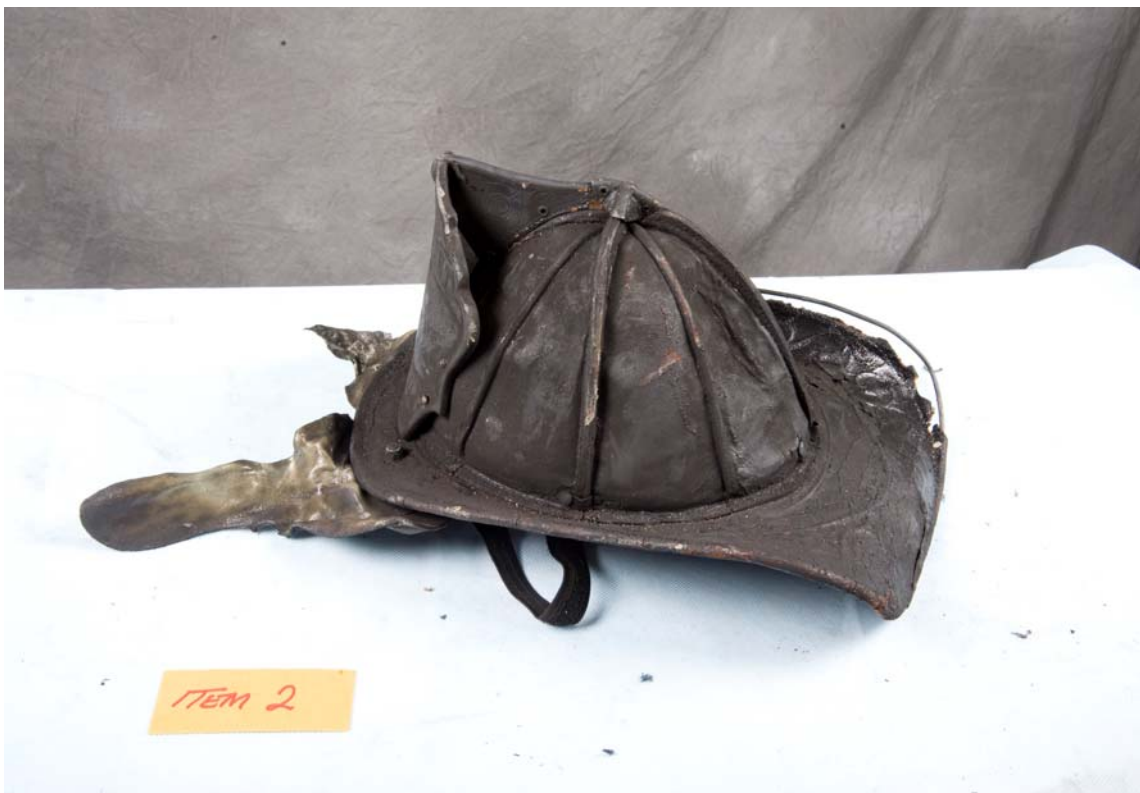
Note heat damage to helmet and the carbon material on the helmet

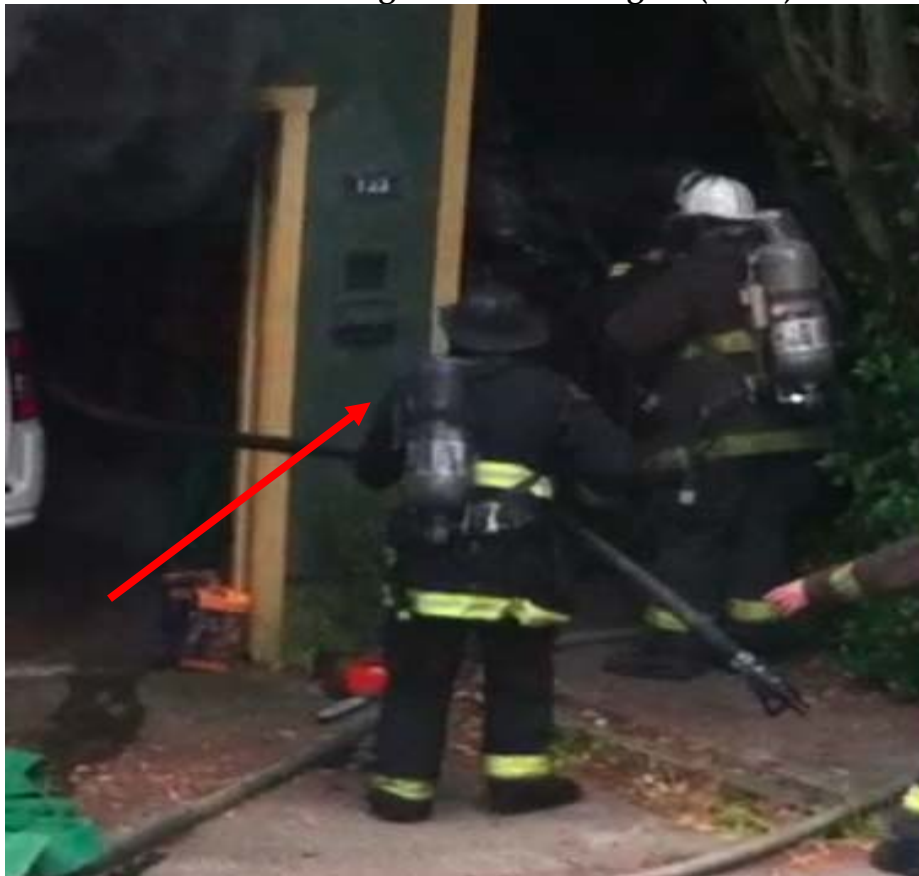
Note Engine 24 Officer's gear (sooted after attempting to make entry through the garage)

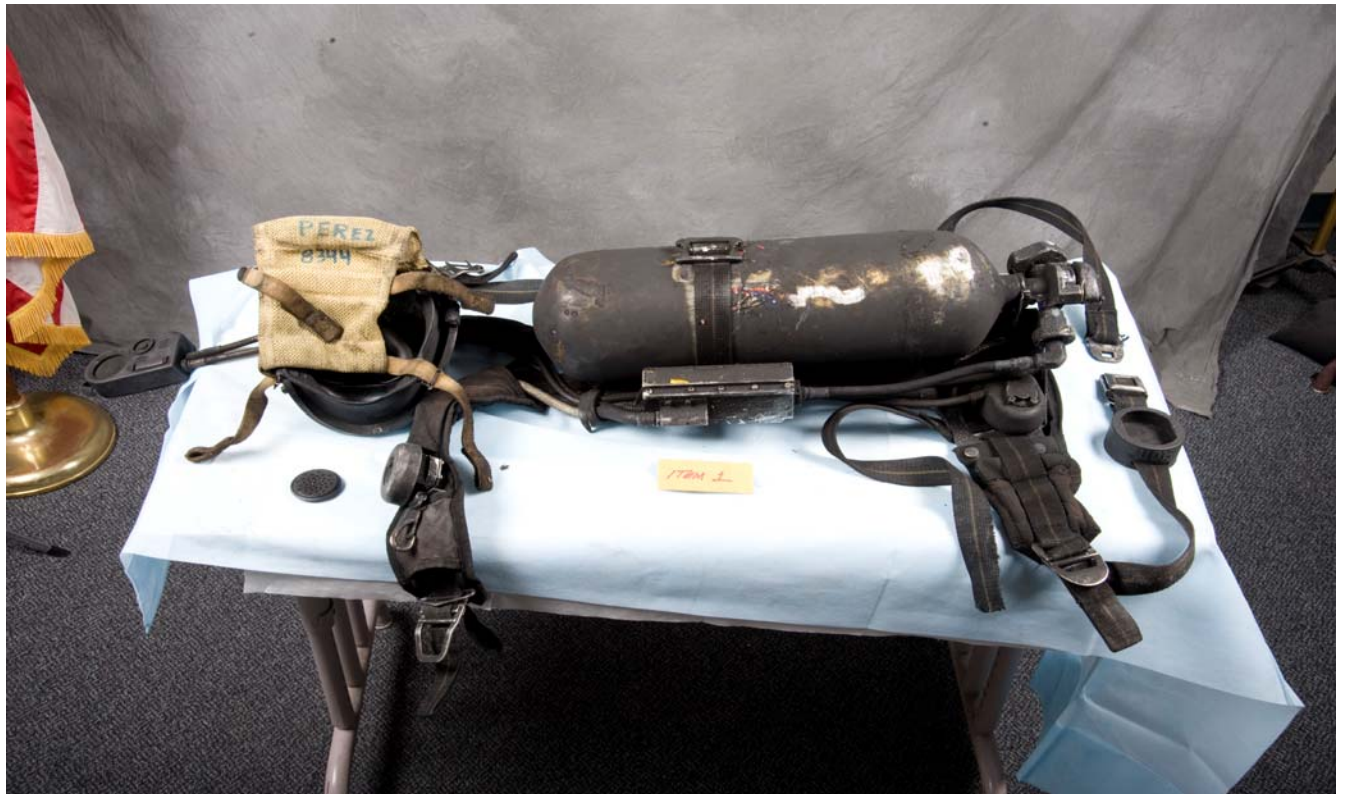
Victim 1's SCBA note the heavy sooting

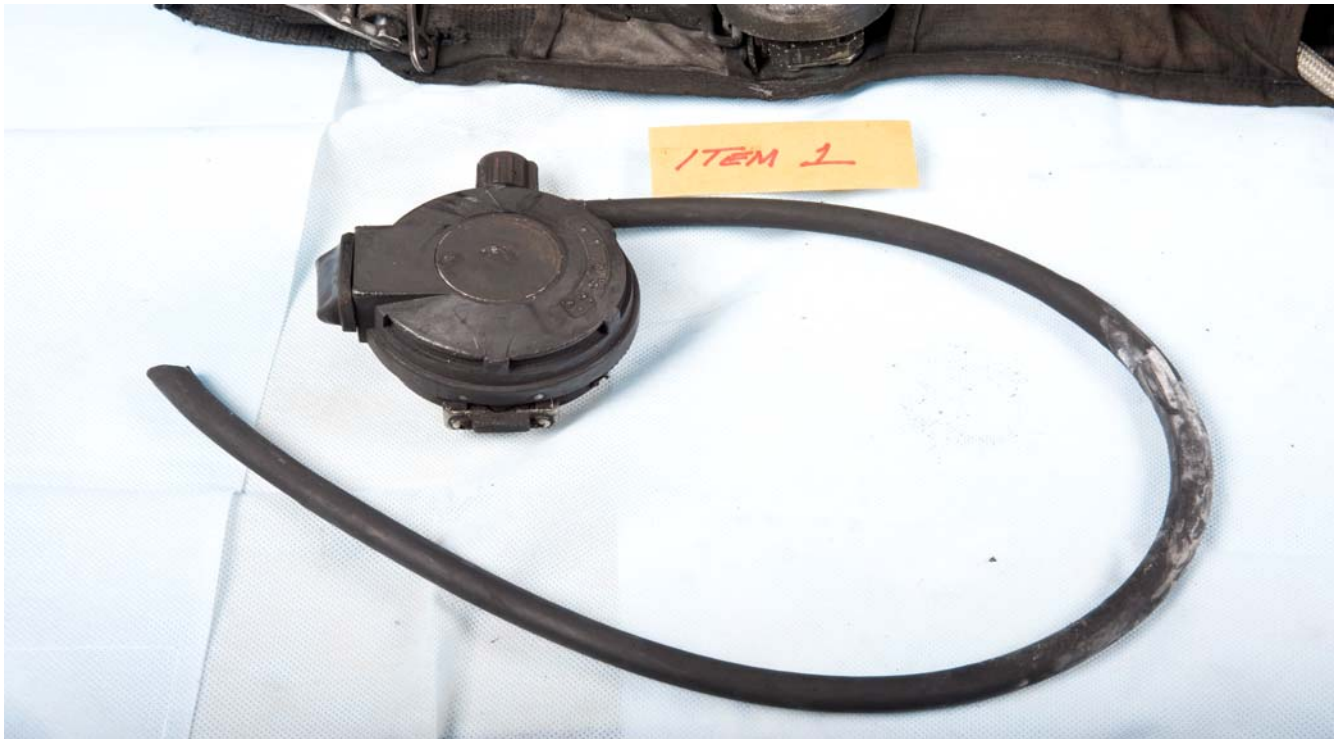
Victim 1's SCBA low pressure hose. This hose was cut during rescue operation (hose/mask was wedged under vehicle's tire in garage).

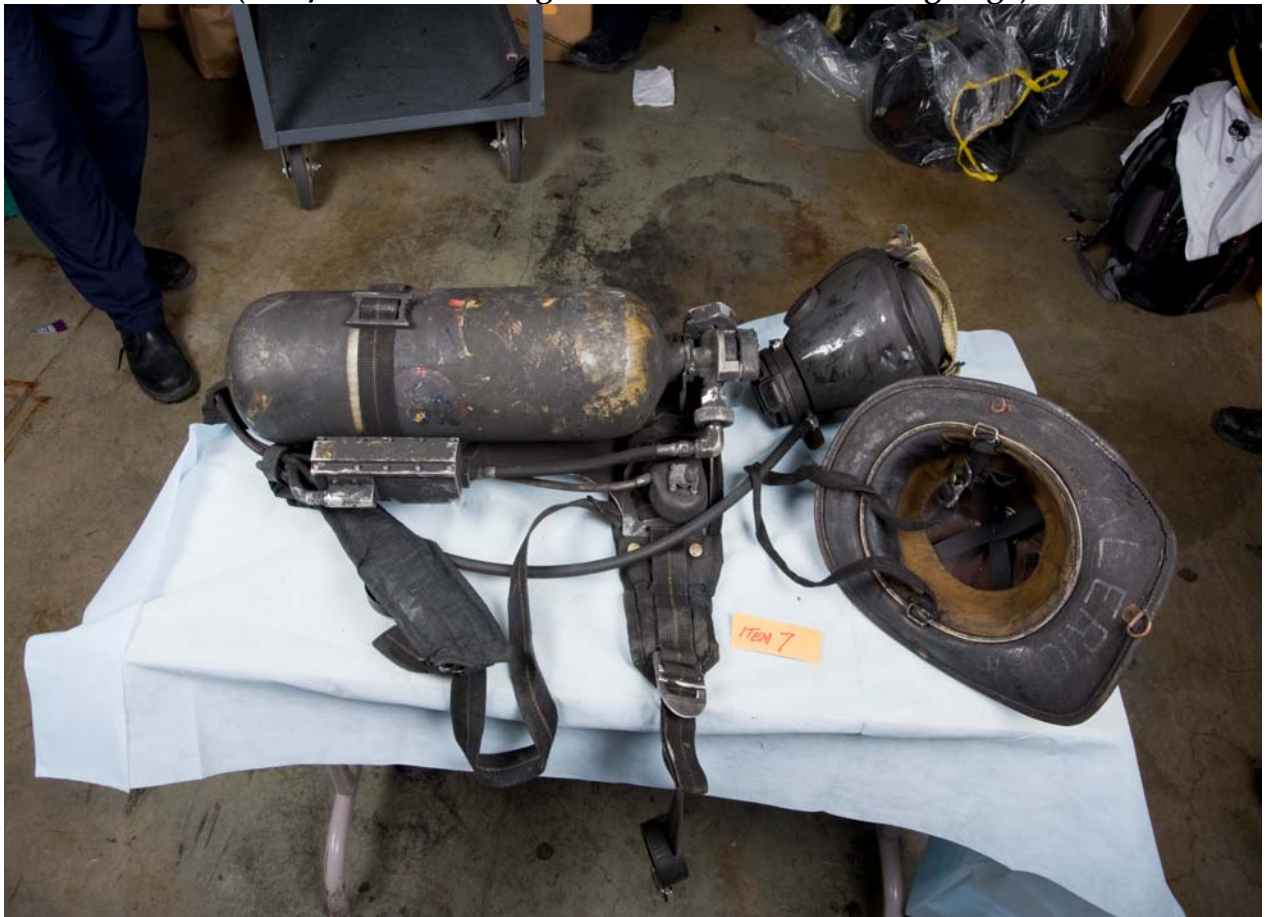
Victim 2's SCBA with Helmet, note the heavy sooting.

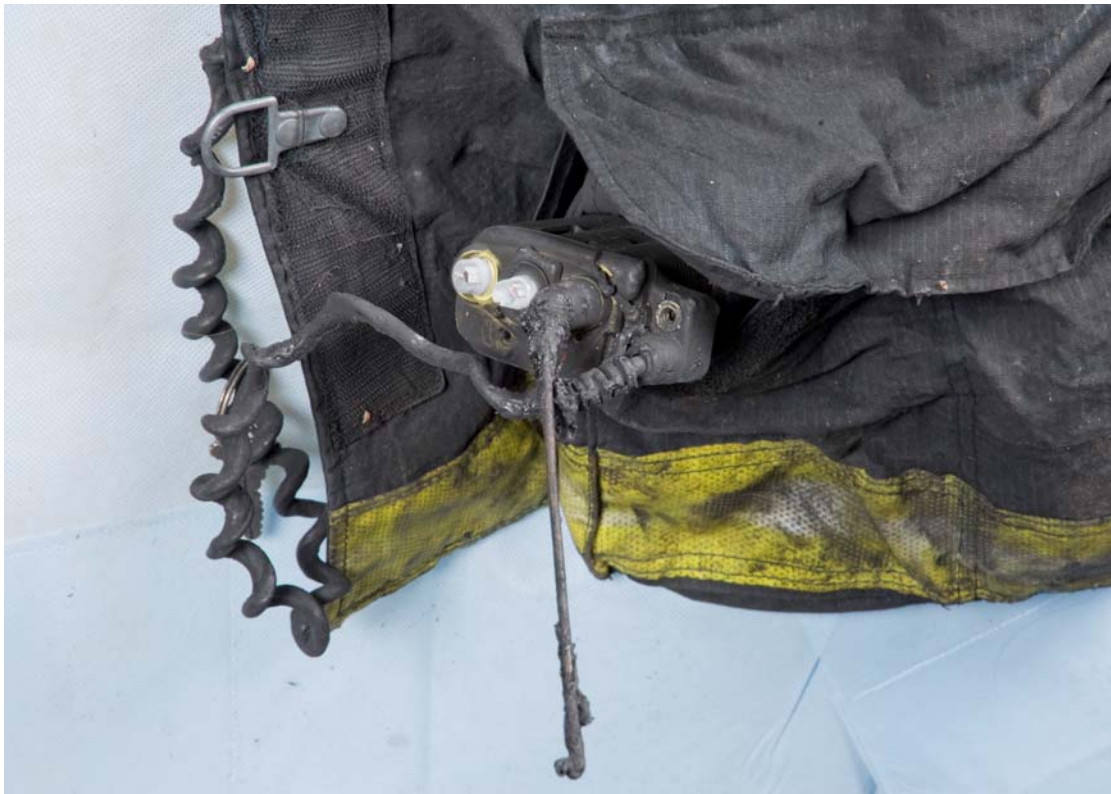
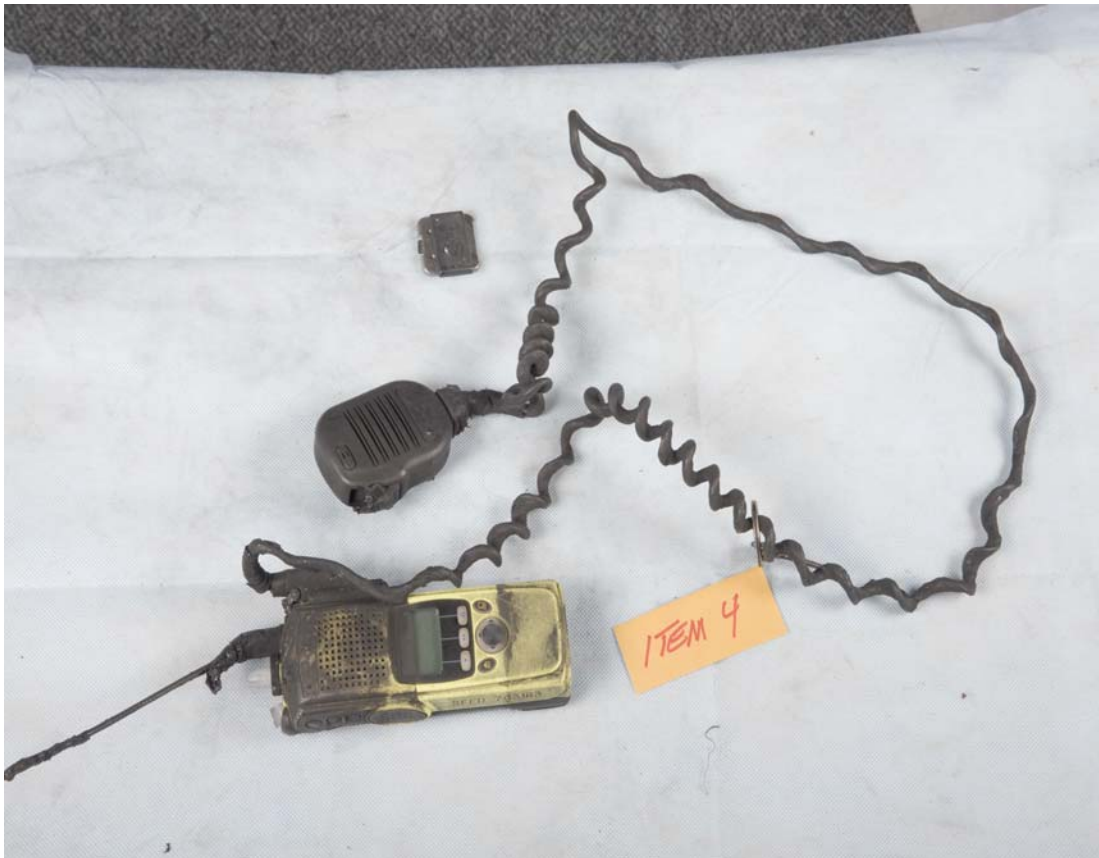
Victim 1's radio

All members operating on the fireground were equipped with an 800 Mhz Fire Department issued portable radio. All Firefighter's radios were equipped with remote speaker/microphones. Victim 1 and 2's radios showed extreme heat damage.

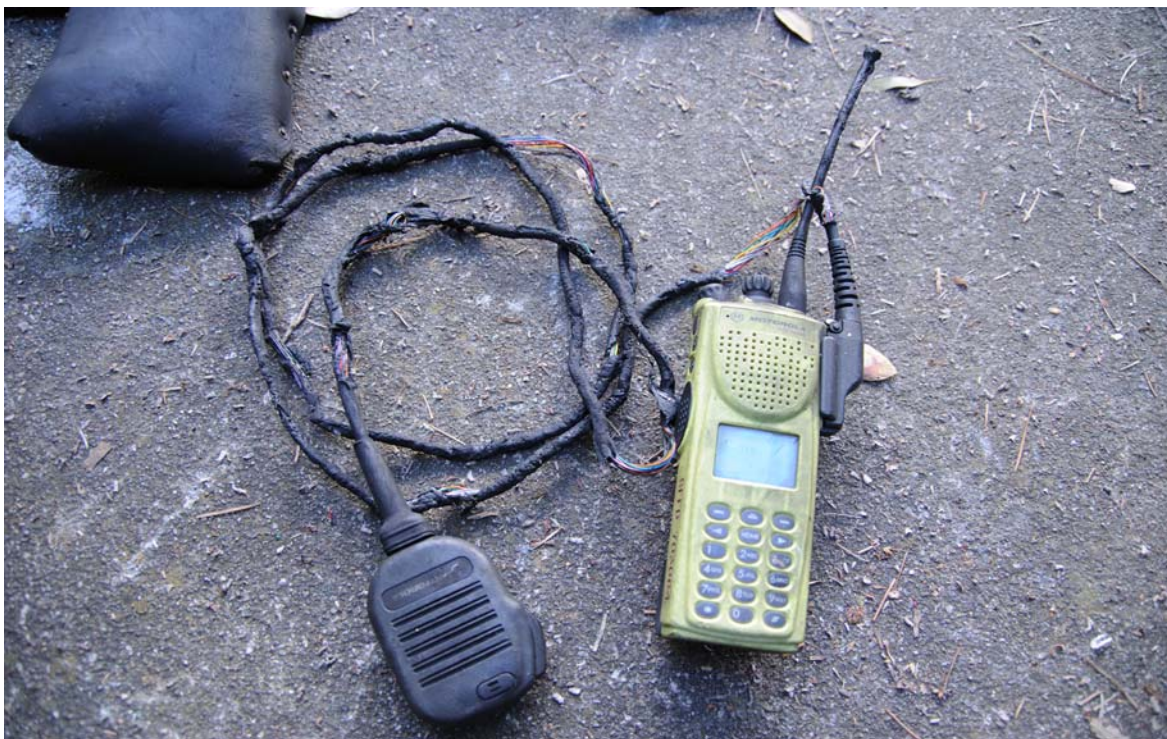
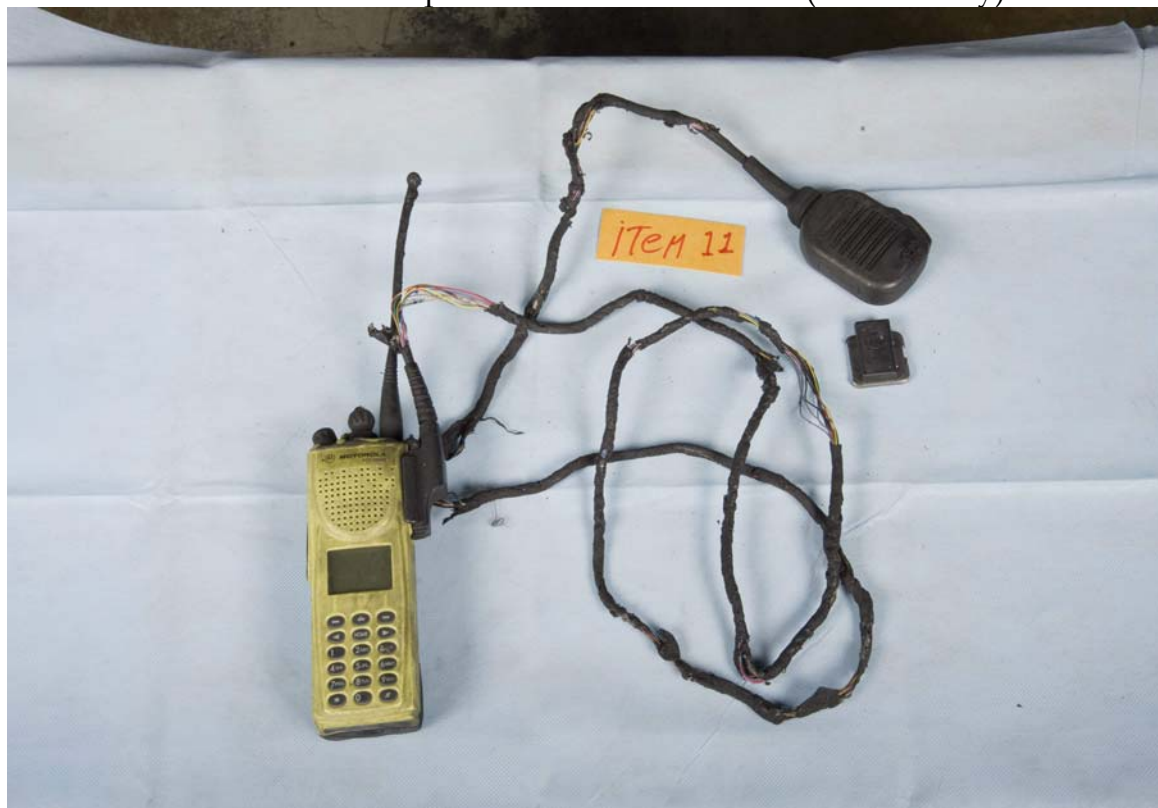
Victim 2's portable radio at the scene (on driveway)
