SAN FRANCISCO FIRE DEPARTMENT

**Safety Investigation Report
Line of Duty Deaths
133 Berkeley Way
June 2, 2011
Box 8155
Incident # 11050532**

February 2012

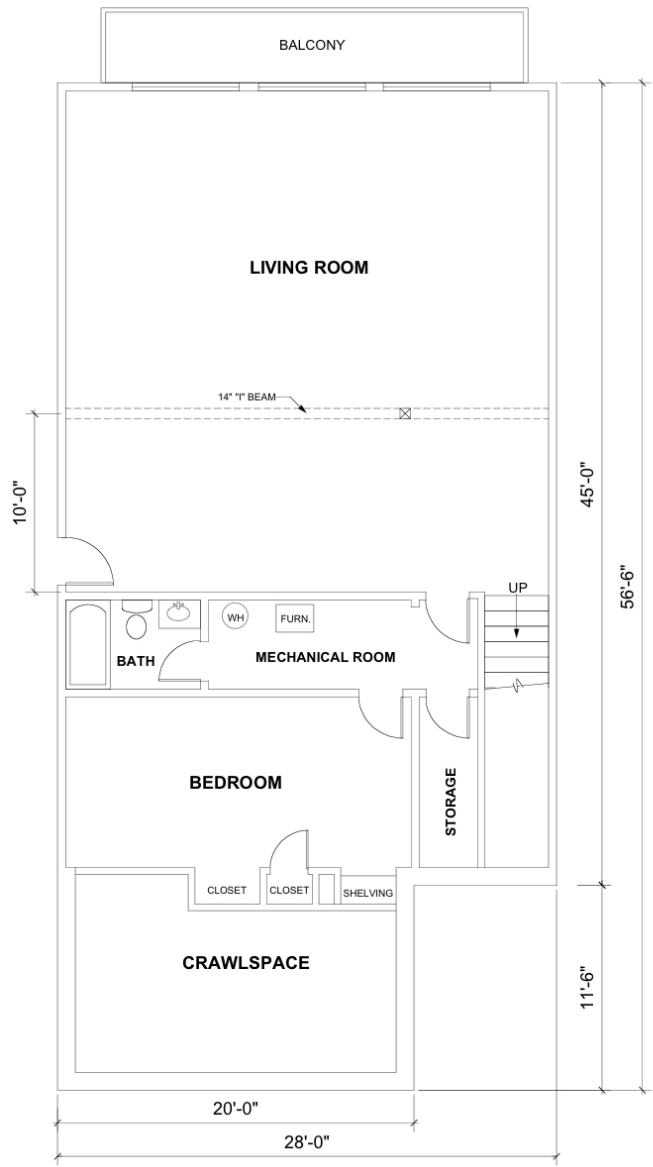
SUB-LEVEL I
SCALE APPROXIMATE

The investigation identified that the failing of the window on Sublevel 1, located near the seat of the fire and directly across the stairwell leading to the ground floor, led to the extreme fire behavior which ultimately caused the death of two Firefighters. This fire was in a stage of deprived oxygen when the window failed, causing a rapid extreme high heat event to occur. The extreme heat followed the natural flow path up the interior stairs where Victims 1 and 2 were located.

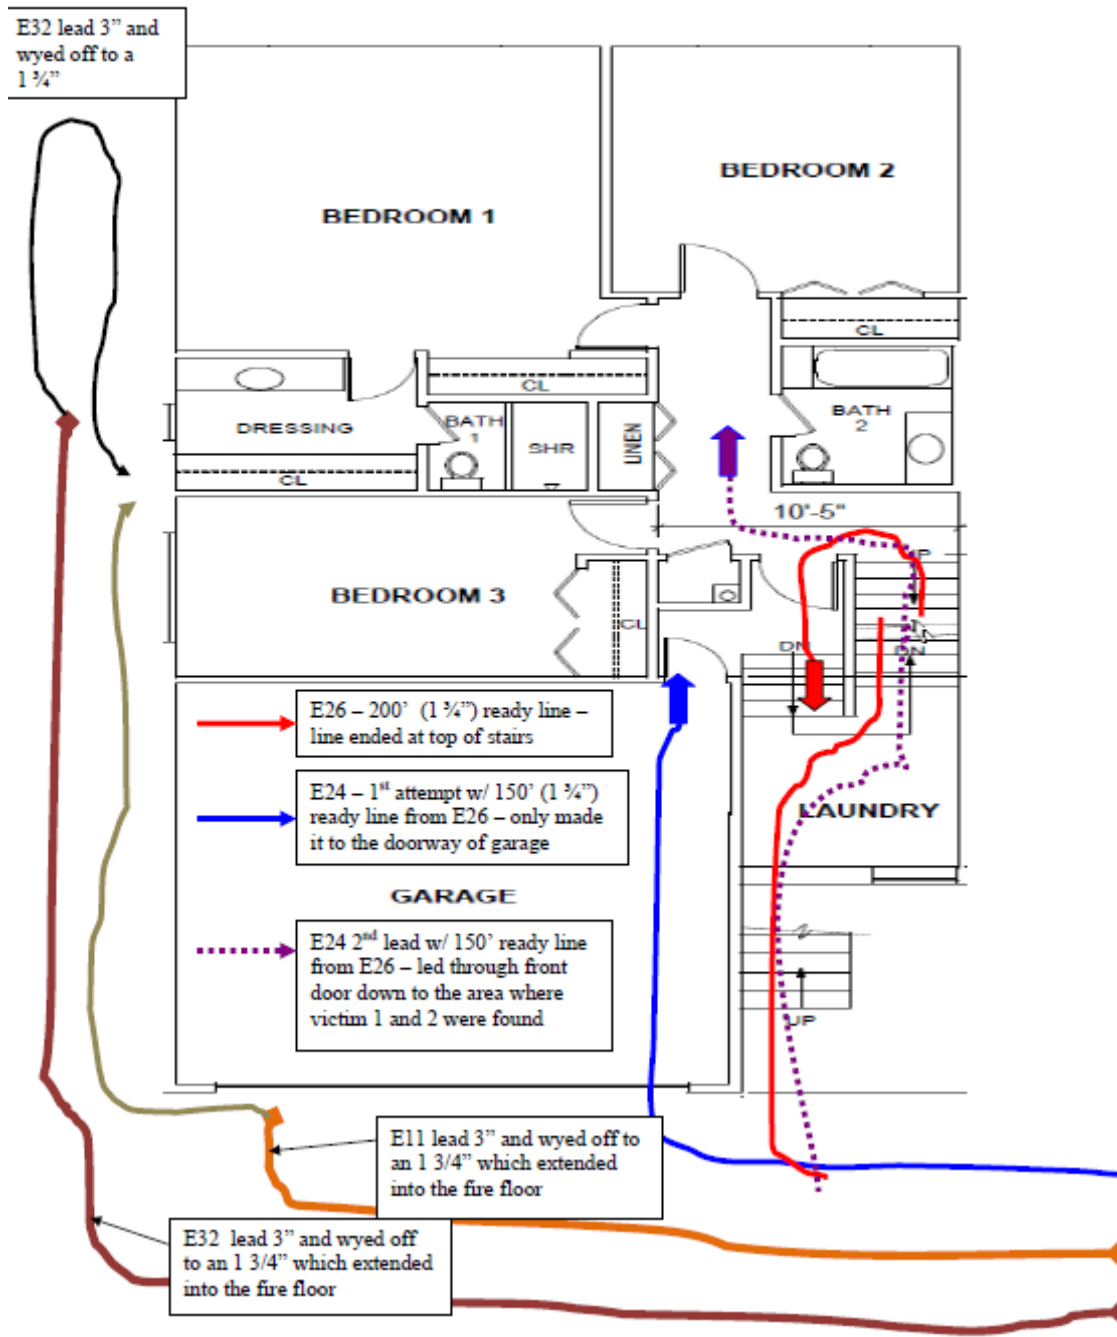
Diagram 1

Engine 24 responded with one Firefighter understaffed due to member being authorized to obtain meal supplies for the Company. There was also a misunderstanding of terminology of hoseline selection. Engine 24 Firefighter/Paramedic thought his Officer was requesting a large line (2 ½ inch attack line), while Engine 24 Officer was actually requesting a 3 inch line with a wye. After hearing members of Engine 26 inside the door to the vestibule on the ground floor, Engine 24 Officer decided to lead a 150 ft. ready line through the garage to back up Engine 26. Aware that this line was 50 feet shorter, Engine 24 Officer felt he could reach them quicker this way. Engine 24 Officer was positioned on the nozzle. Engine 24 Officer does not recall hearing a Personal Alert Safety System (PASS) alarm until Victim 1 was moved. Engine 24 Officer does remember seeing strobe light from PASS device while moving Victim 1. Engine 24 Officer indicated that he attempted to radio "Mayday" but was unable to, due to radio traffic. Engine 24 Firefighter/Paramedic, concerned about Victim 2 suffocating, quickly removed the Victim's SCBA and checked for any signs of breathing. Engine 24 Driver secured the garage door by placing visegrips on the door channel. Engine 24 Officer received a burn to his ear and was later transported to San Francisco General Hospital and released after treatment.

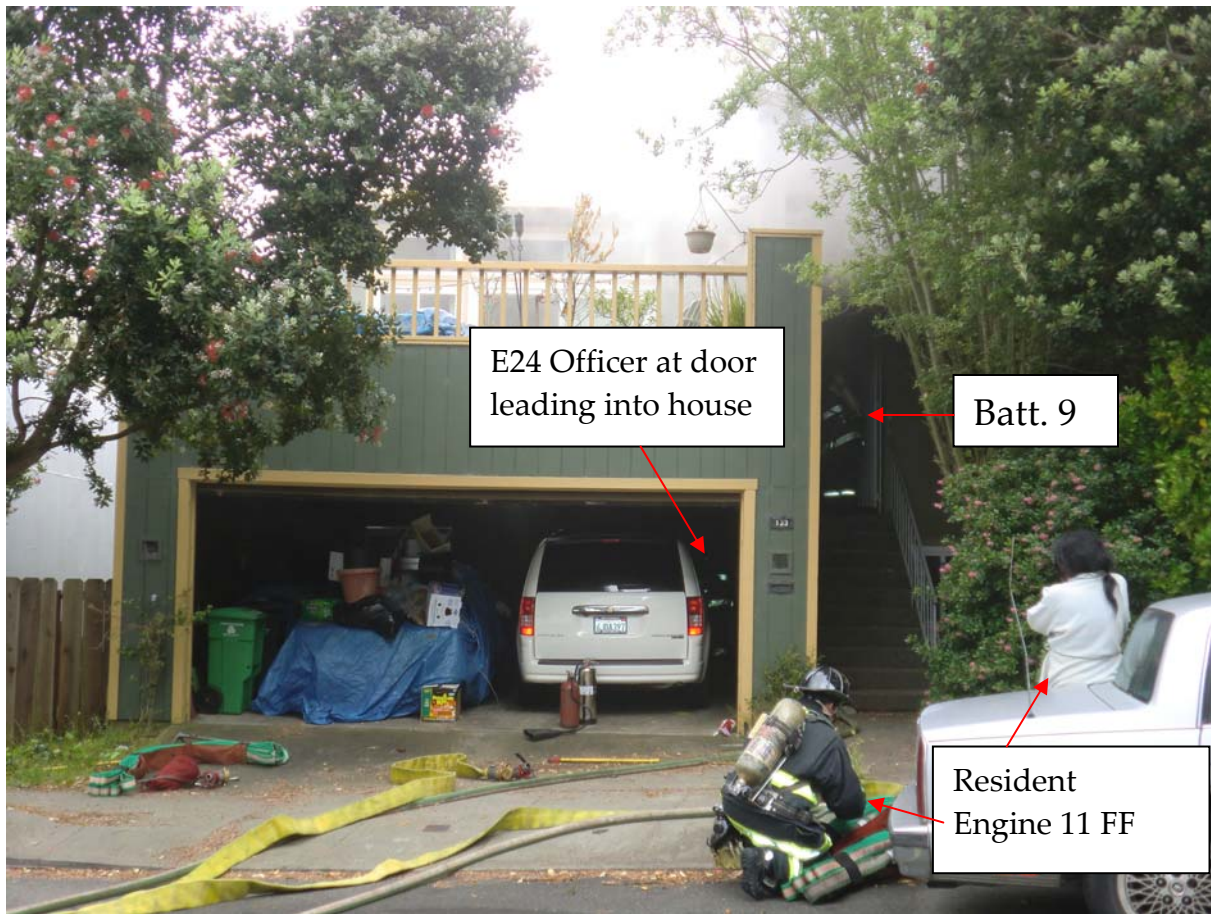
10:53:52 Battalion 9 in front doorway, prior to descending stairs to meet with Engine 26.

In this picture, Engine 11 has deployed large line and a member from Engine 11 is breaking a hose bundle to connect to the wye. Engine 24 Officer is in rear of garage near the front right corner at the door leading into the house checking conditions and access. Resident is standing next to car. (0855)

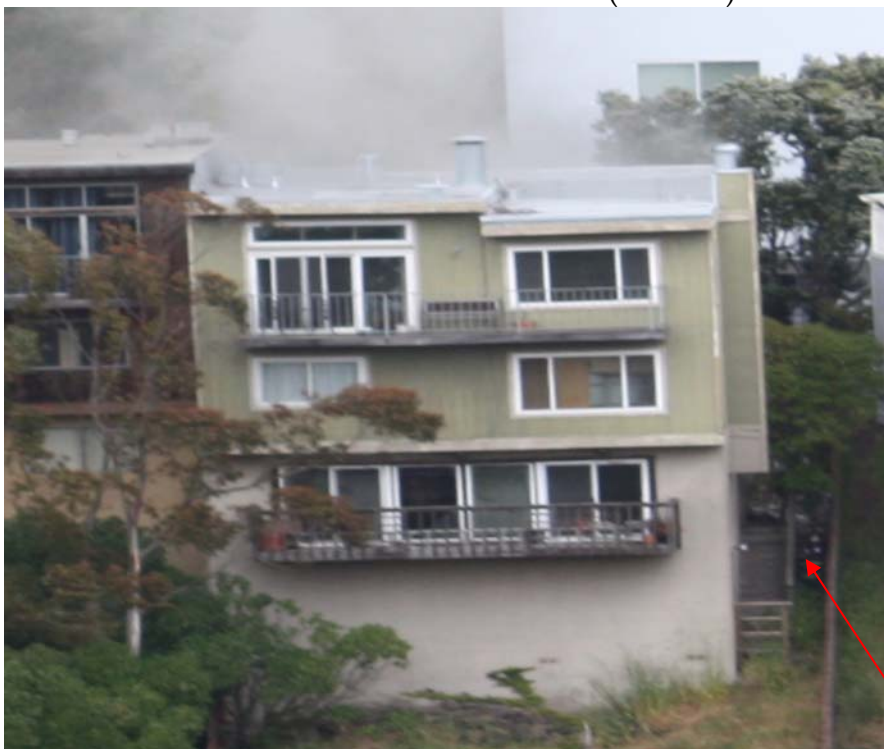
10:57:11 First picture showing conditions from the rear of the building. Note **Battalion 9** coming down the hill side on the Bravo side. Noticing a metal gate on the door to Sublevel 1, Battalion 9 requests a forcible entry tool. (6565)

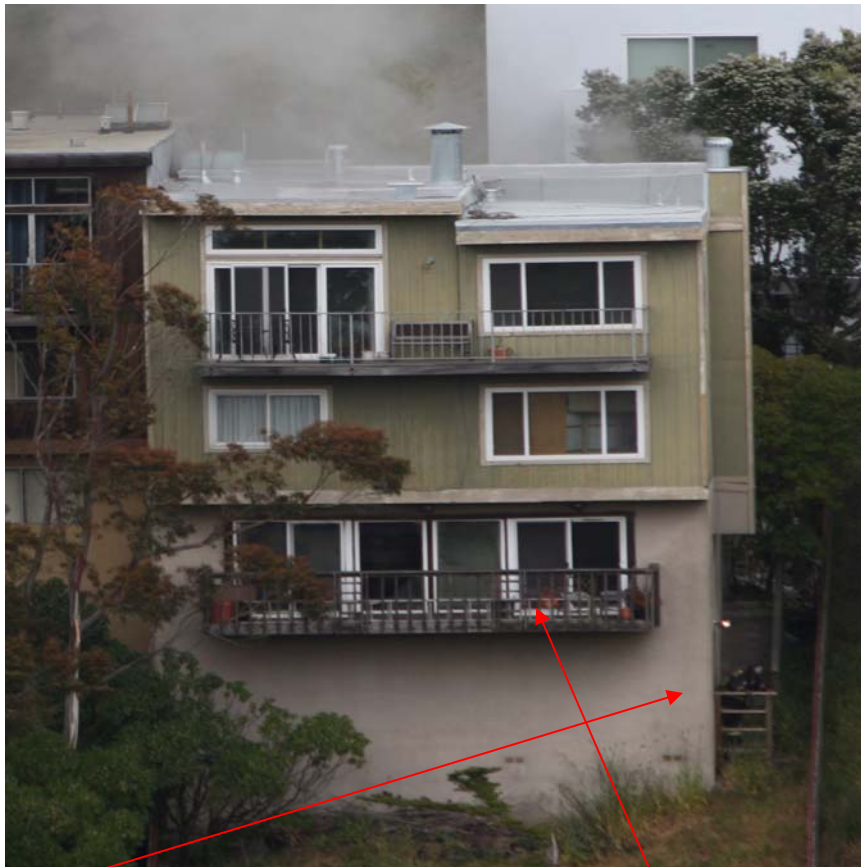
10:57:18 **Battalion 9** forcing entry into Sublevel 2. Note fire in lower right hand window (6567)

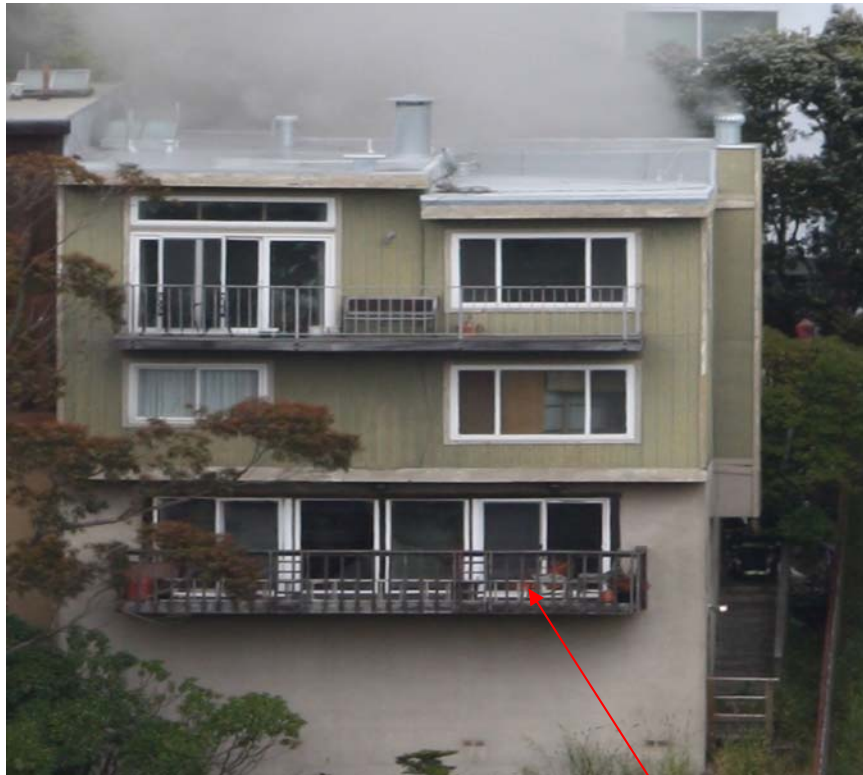
10:58:21 Battalion 9 is checking door to Sublevel 1. Note fire in window is growing (6572)

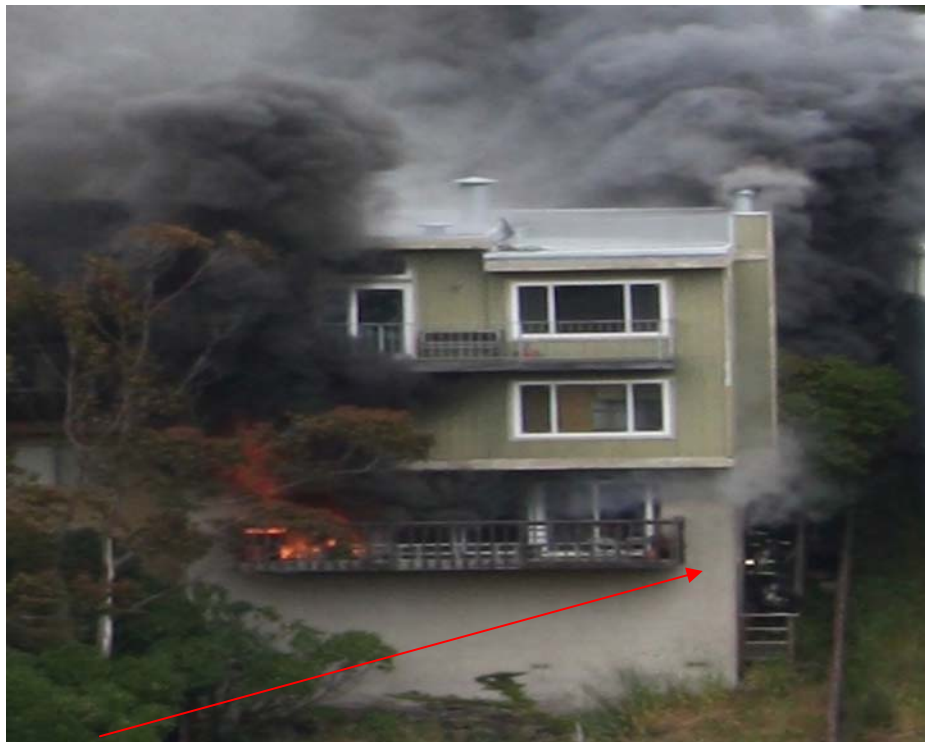
10:59:23 **Engine 11** and **Battalion 9** make entry to Sublevel 1. Battalion 9 requests additional hoseline to assist. Note the smoke change on the Bravo side along with the change in the front. (6577)

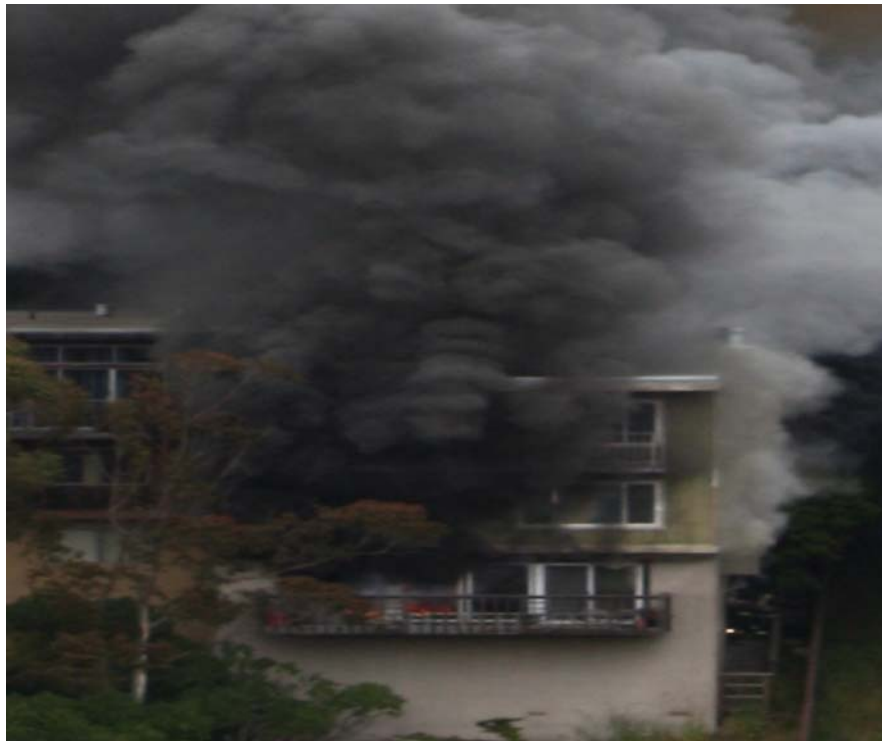
10:59:54 Note change of smoke color coming front Sublevel 1 door (Bravo Side) due to water application (6580)

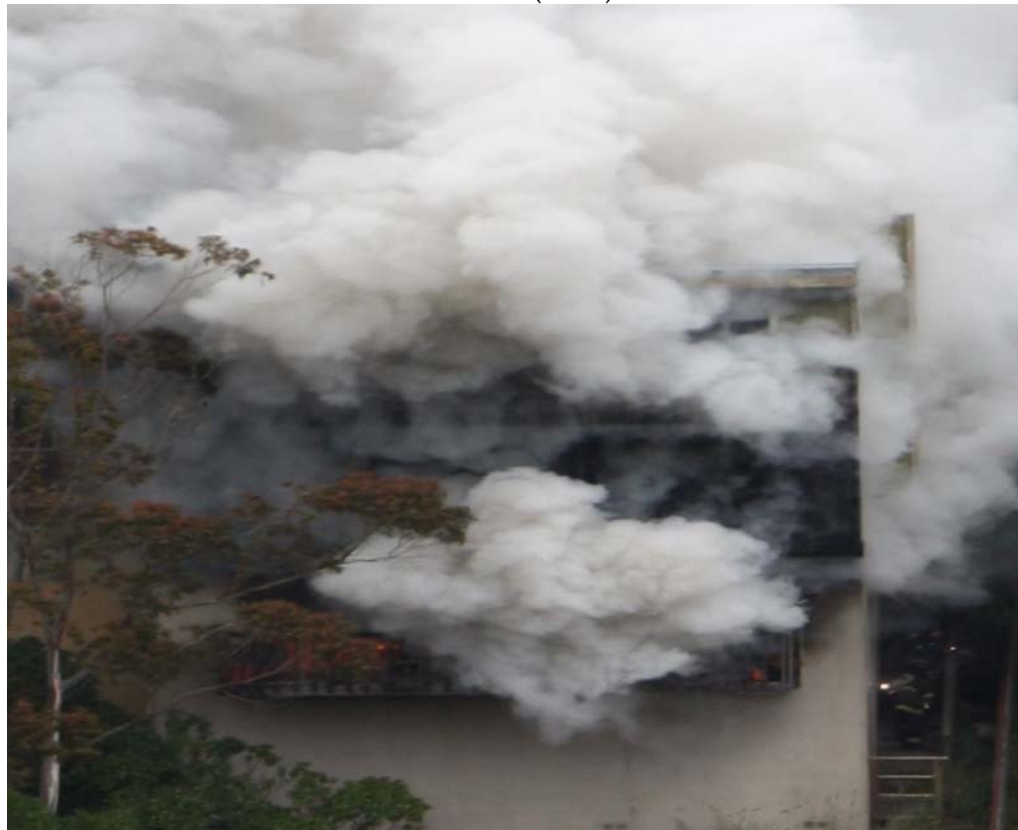
11:02:21 Note bulk of fire has been knocked down (6596)

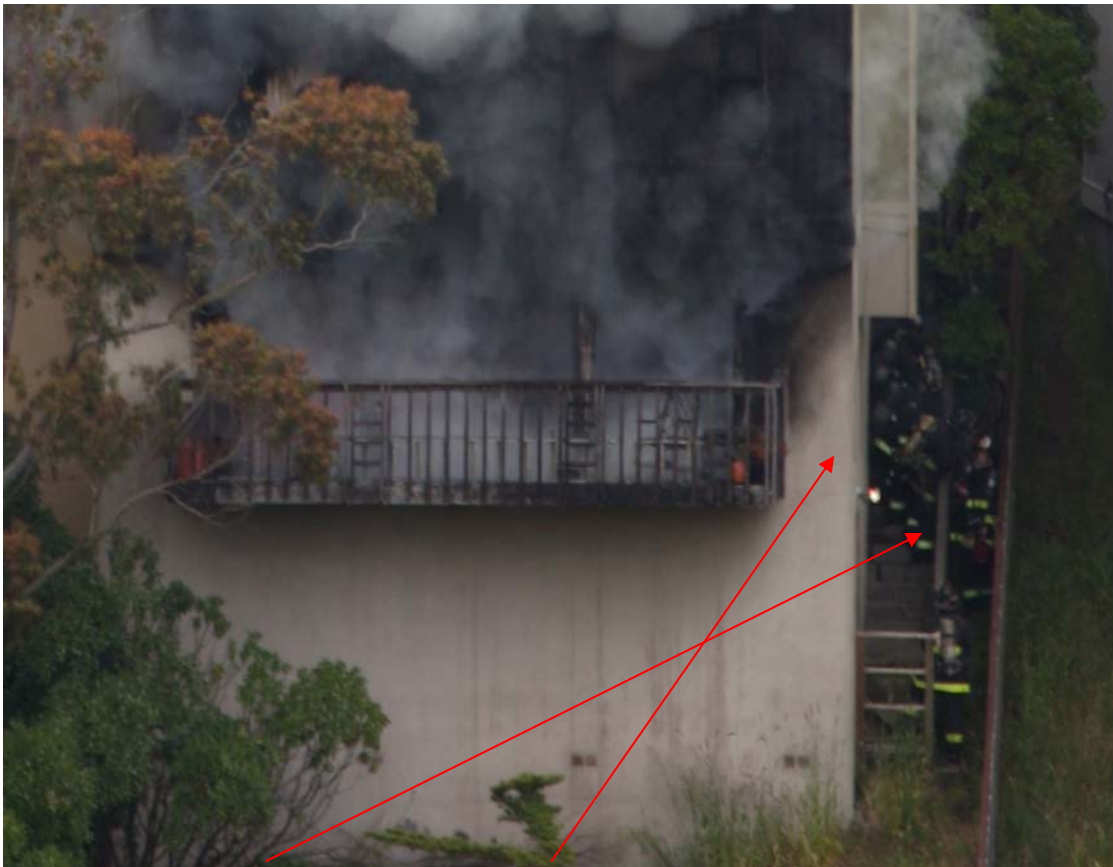
11:04:08 **Engine 32** on hill and **Rescue 1 Team A** on stairs to fire room (6602)

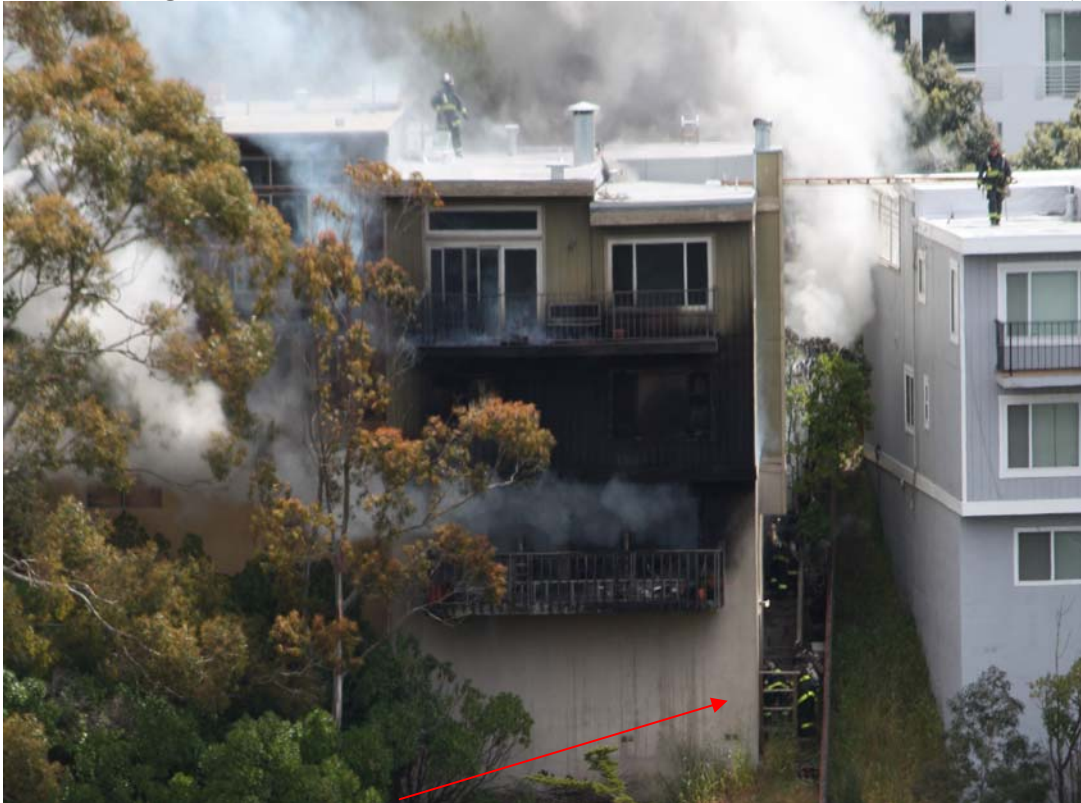
11:04:44 **Engine 32** at the bottom of stairs (6604)

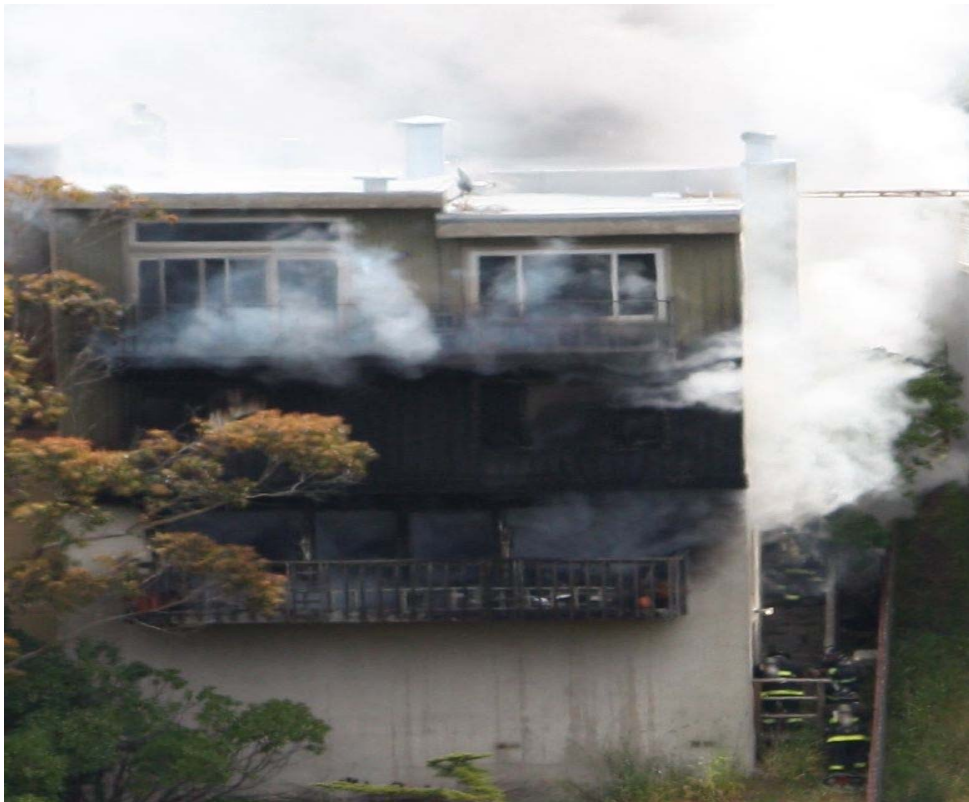
11:04:51 Battalion 9 reported in this time frame that fire was knocked down (6605)

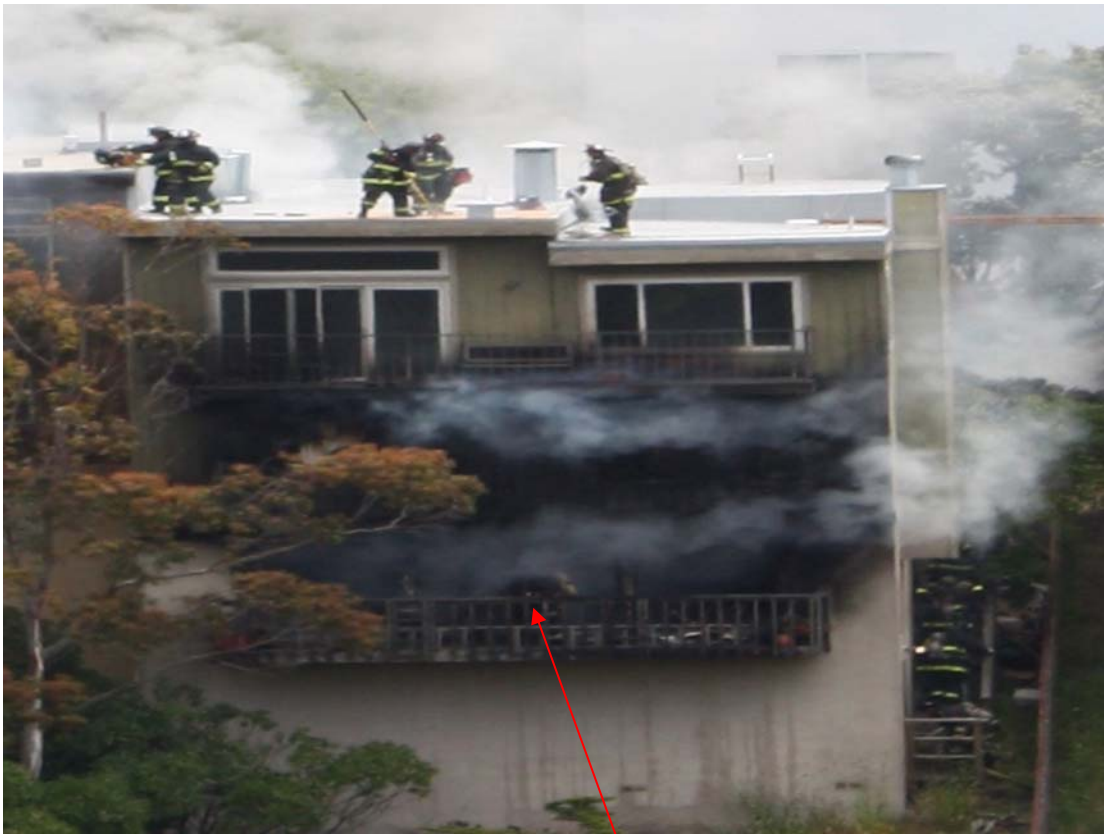
Note Truck 15 and Truck 11 crews on roof and **Battalion 9** on the balcony (6620)

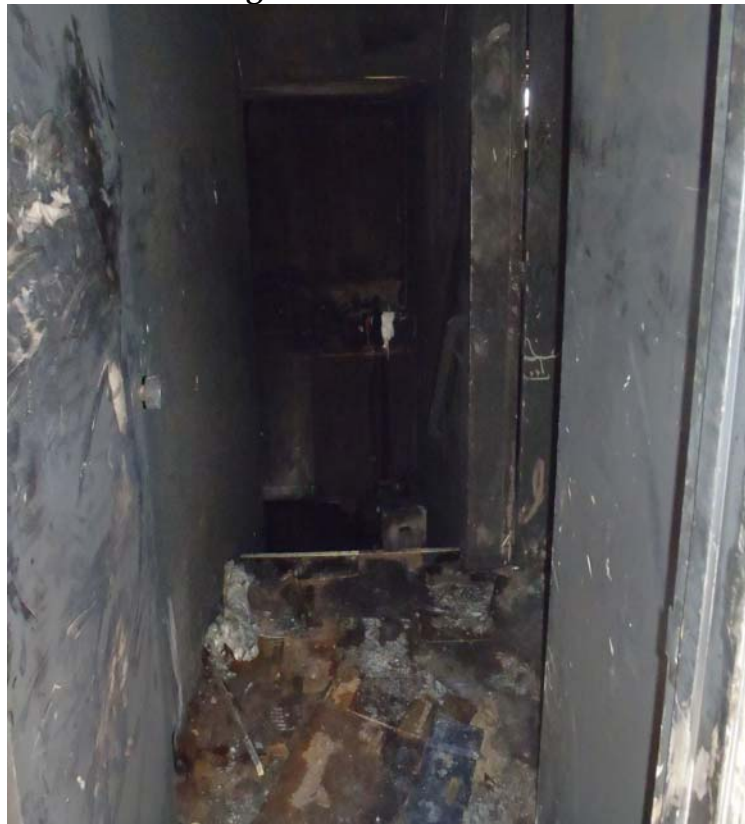
Top of stairs leading down to fire room, note amount of carbon material deposited on the surfaces

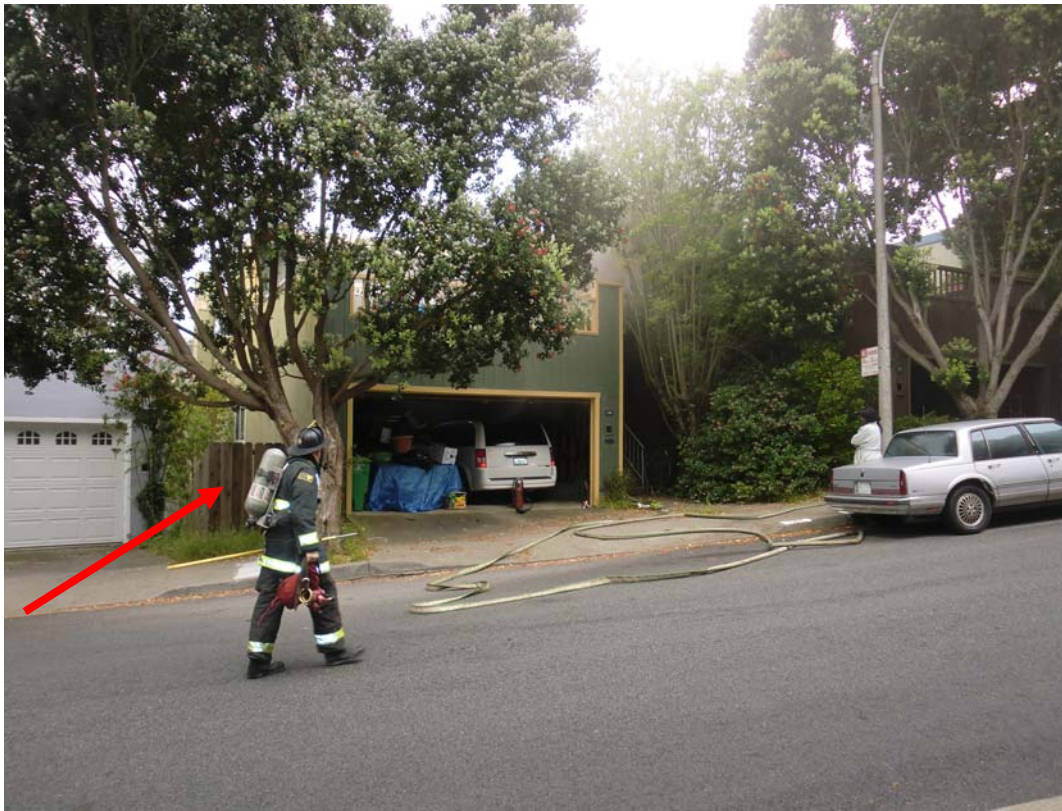
Note Engine 24 Officer's gear (clean)

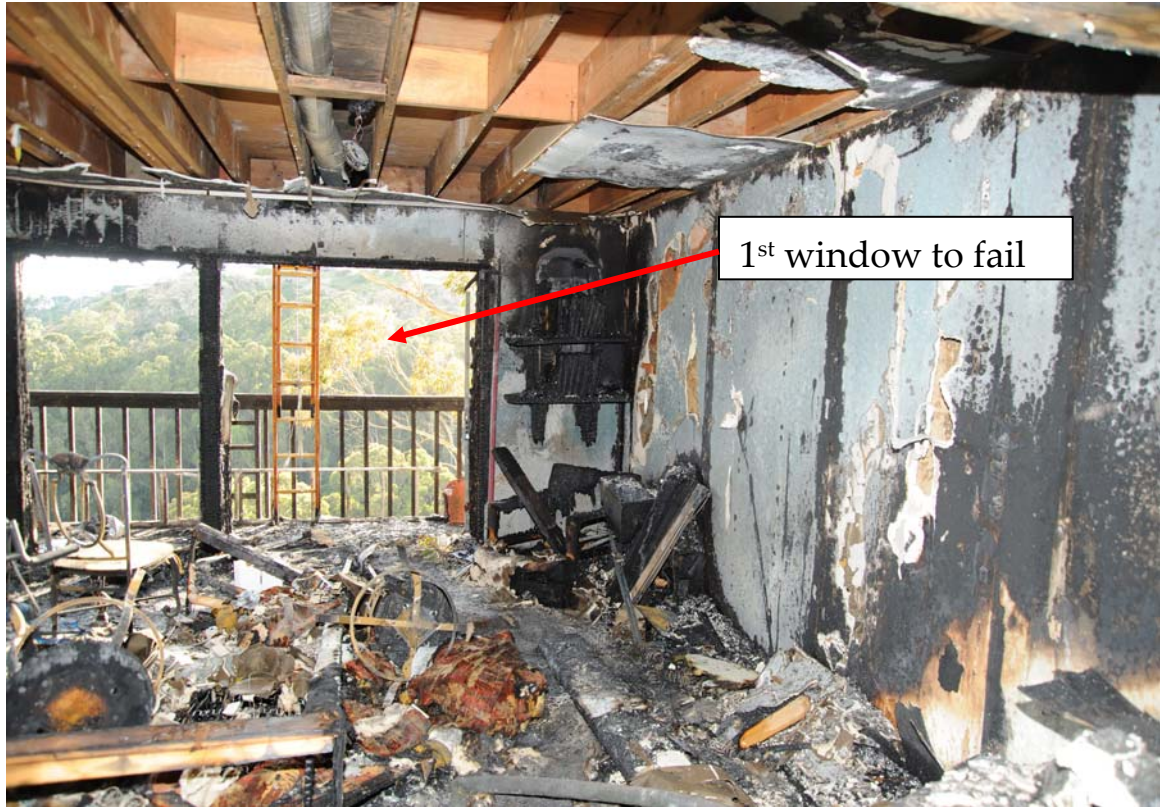
Looking from the bottom of the stairs out the windows and the room of origin

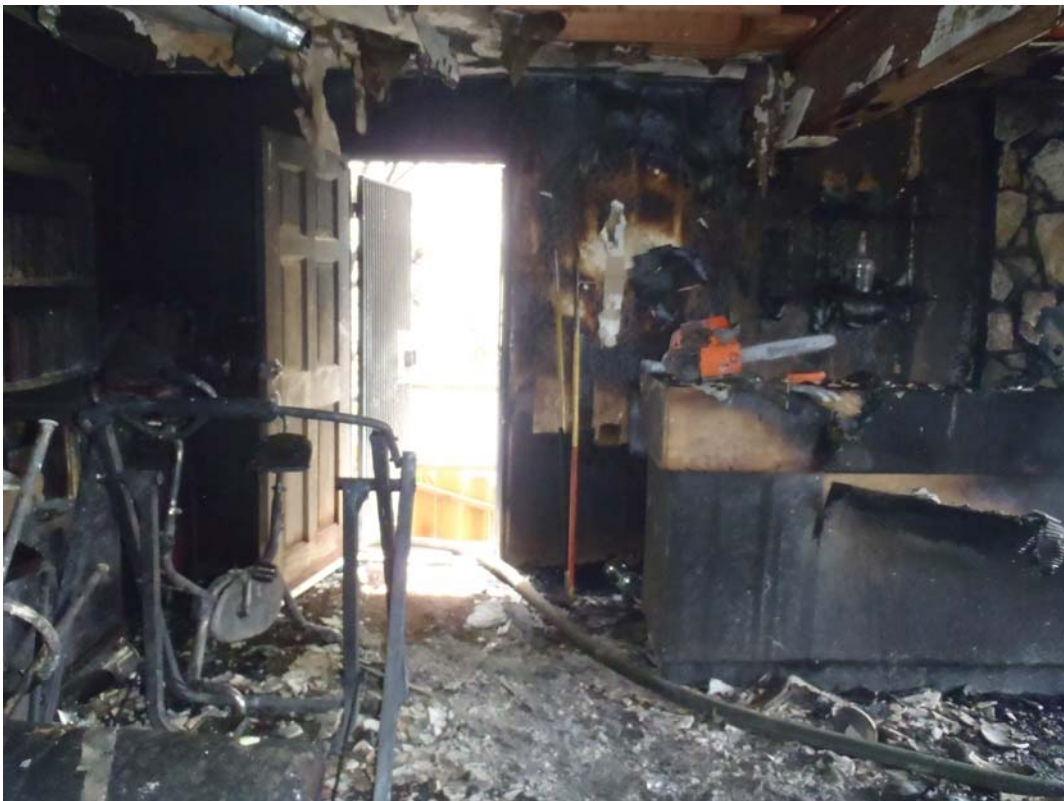
In the fire room looking out towards the door on the Bravo side, this is the door that Engine 11 and Battalion 9 made entry from.

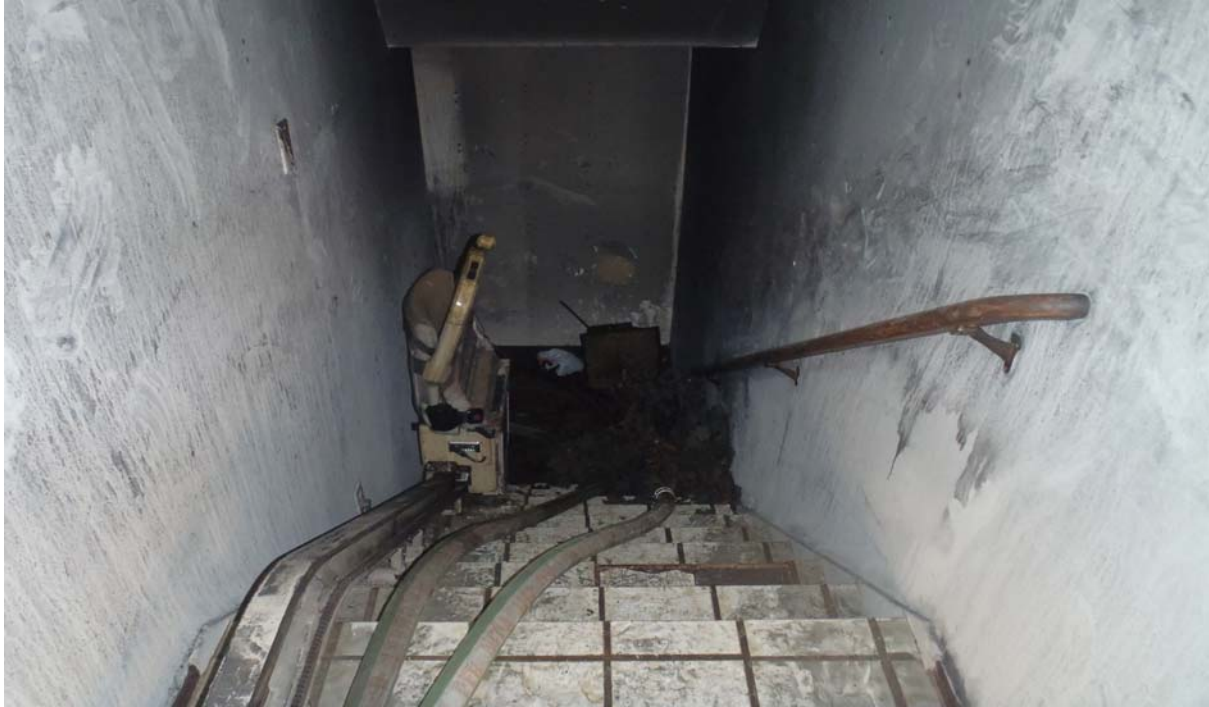
**From the front door area looking down the stairs.
Engine 26 and Engine 24 1 3/4" hose leads down the stairs to ground level**

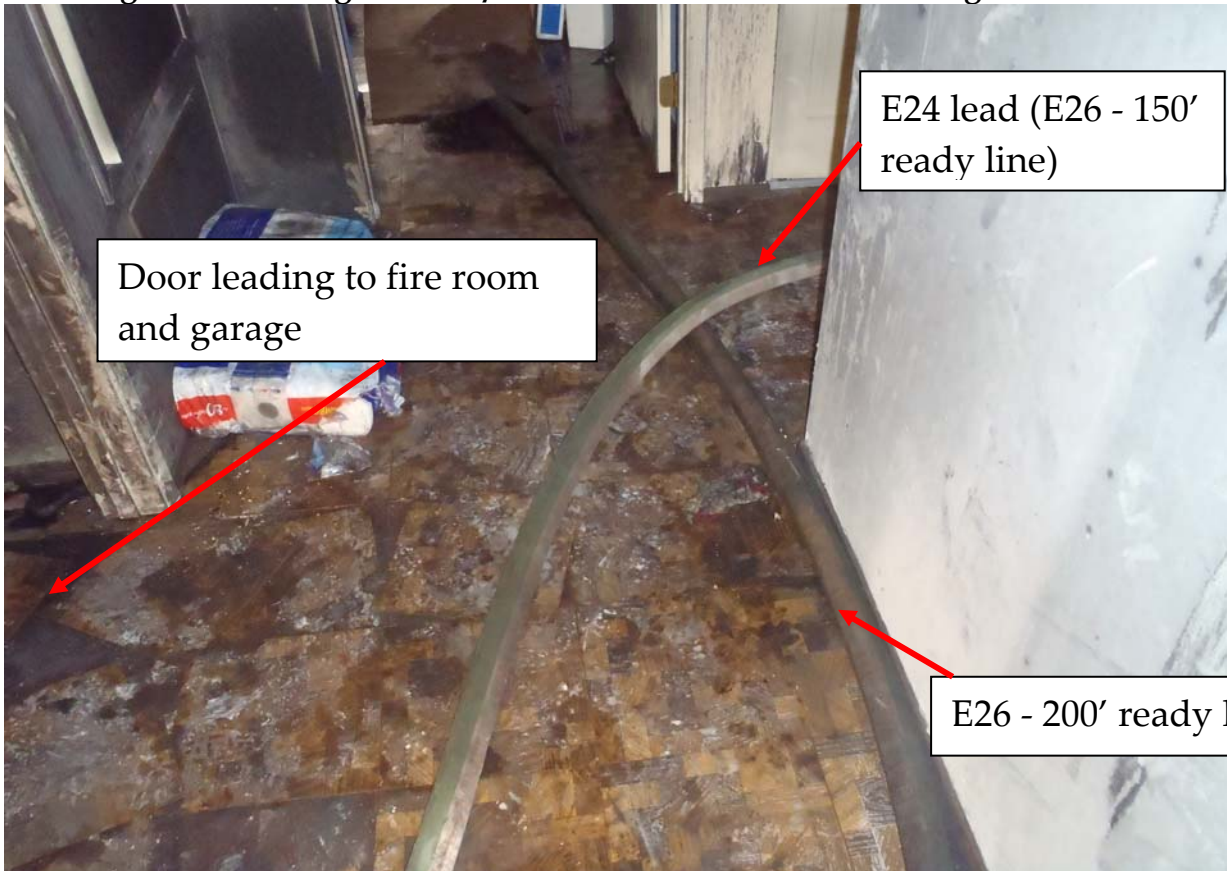
**Looking left from the bottom of the stairs to the left.
Hoselines are Engine 26 and Engine 24 location after the fire.**

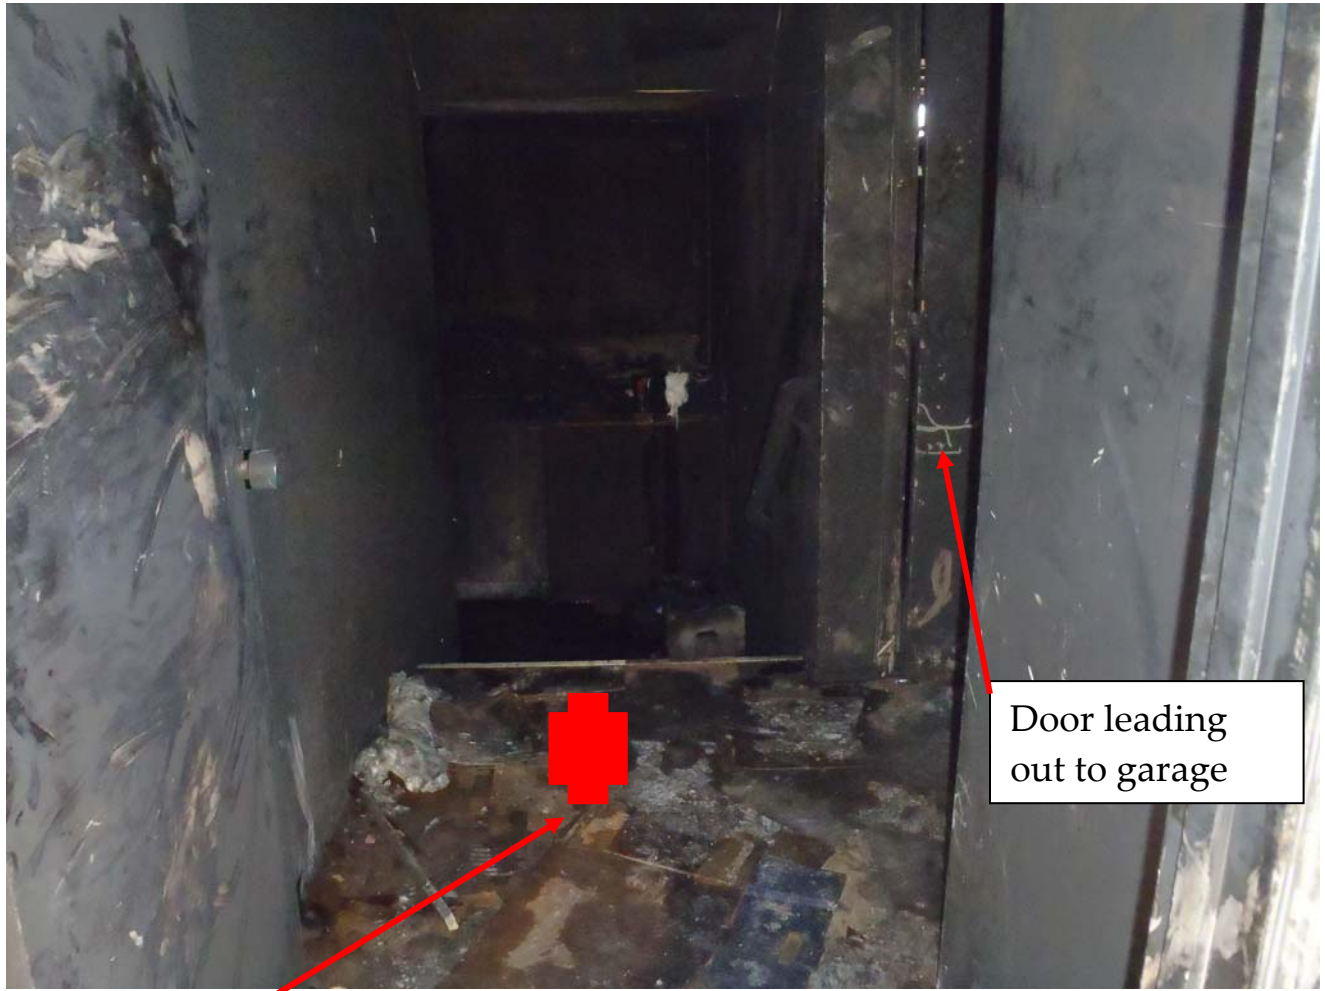
Lieutenant Perez was found in the vestibule area on the ground floor, located just inside the garage door leading into the house. He was found unconscious, unresponsive, face down on or near the stairs leading up from laundry area by Engine 24 Officer (Approximate location indicated by arrow).

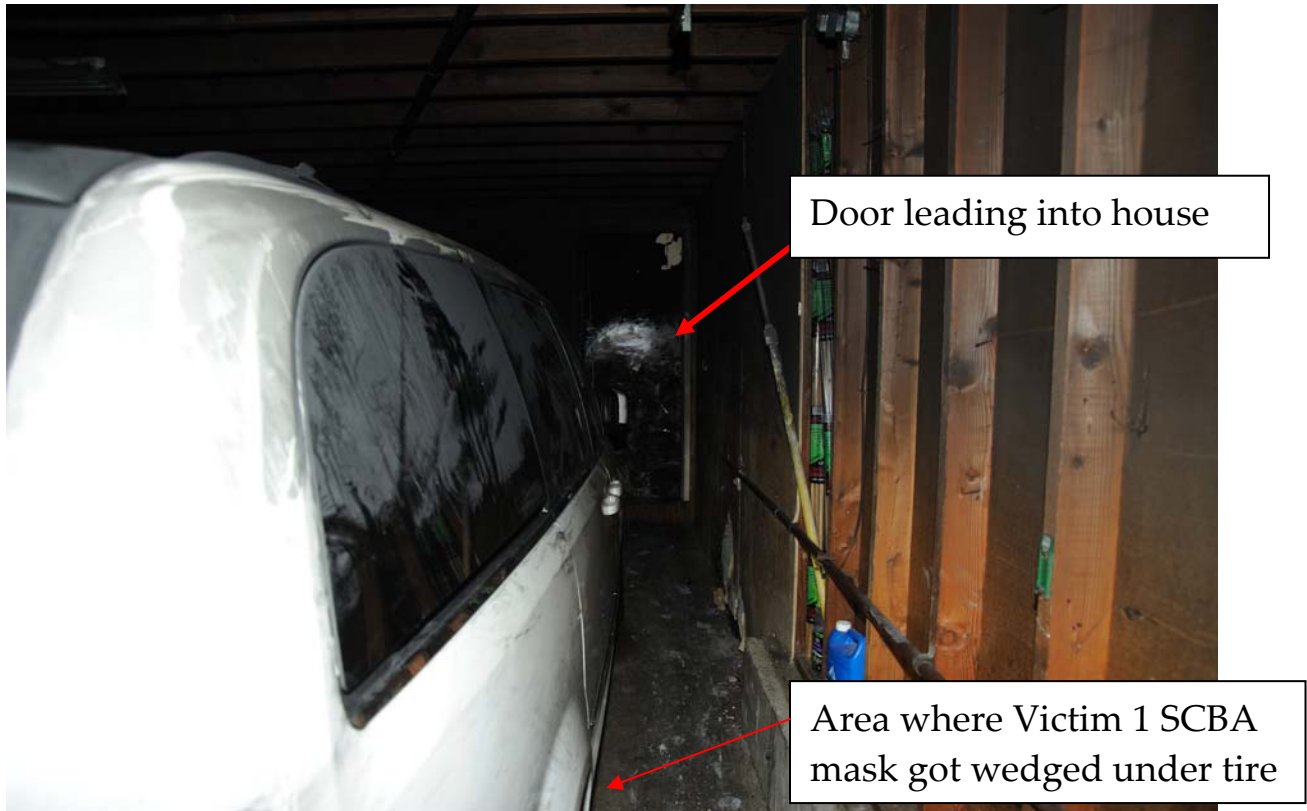
Engine 24 Officer and Engine 24 Firefighter/Paramedic, with the assistance of Rescue Squad 1 Officer, carried Lt. Perez, exiting through the garage door. While moving Lt. Perez, members encountered obstacles due to homeowner's contents, which hampered the rescue. In the process of the rescue, Lt. Perez's SCBA mask got caught under a car tire, which required the members to cut the air hose to the mask. Once Lt. Perez was brought outside the building, members performed CPR.

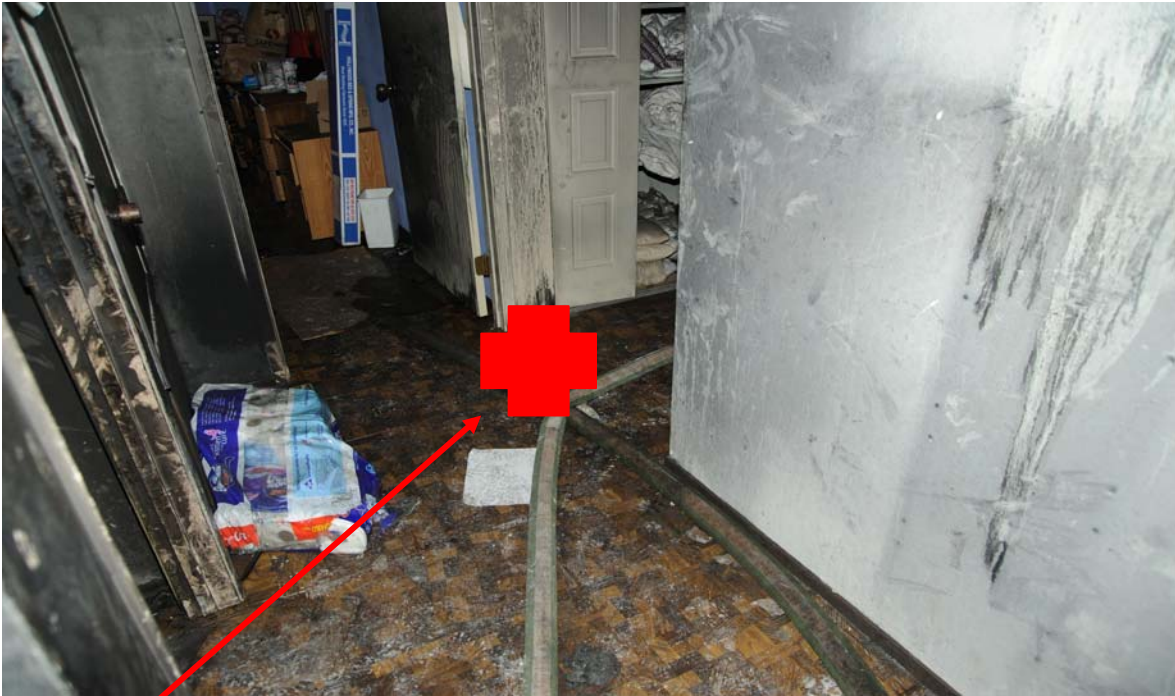
FF/PM Valerio was located in the hallway outside the bedroom/bathroom on the ground floor. He was found unconscious and unresponsive, face down, by Engine 24 Firefighter/Paramedic who moved him to the doorway leading to the vestibule (Approximate location indicated by arrow).

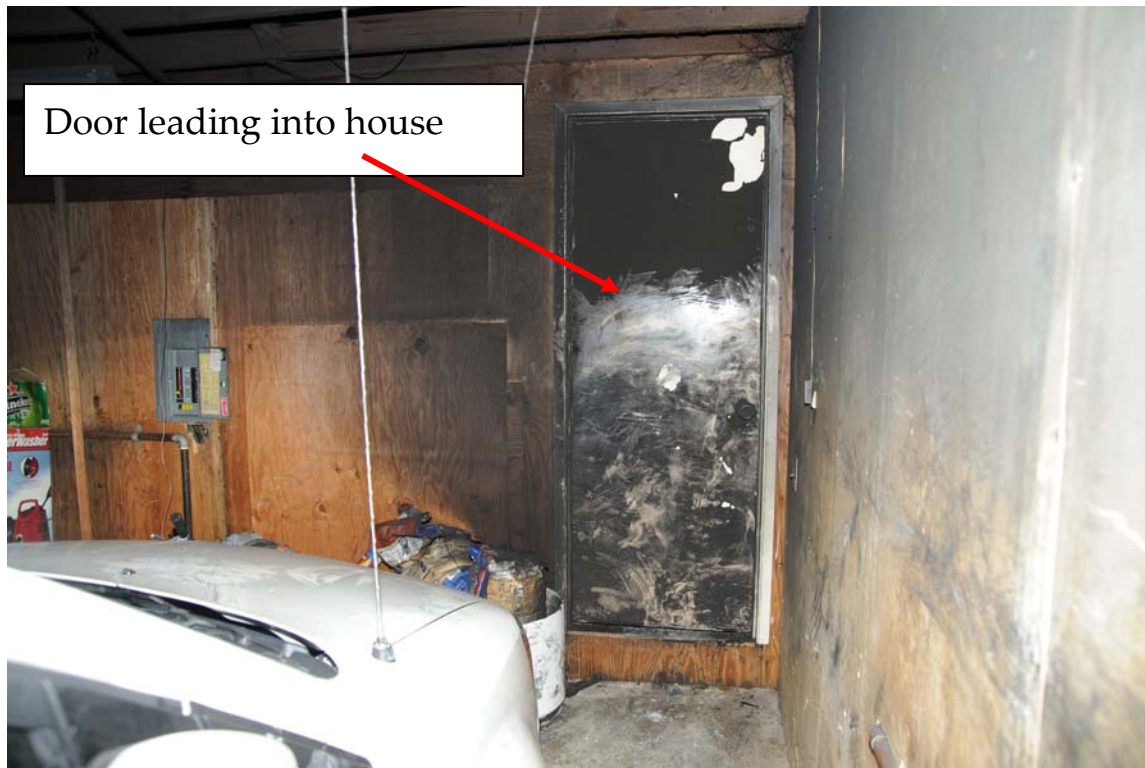
Rescue Squad 1 Firefighter along with Truck 11 Firefighter carried FF/PM Valerio by exiting through the garage, following behind the crew that was carrying Lt. Perez. Once FF/PM Valerio was brought out of the building, members performed CPR and provided medical care. This picture shows the door that both Lt. Perez and FF/PM Valerio were carried out of, through the garage during the rescue.

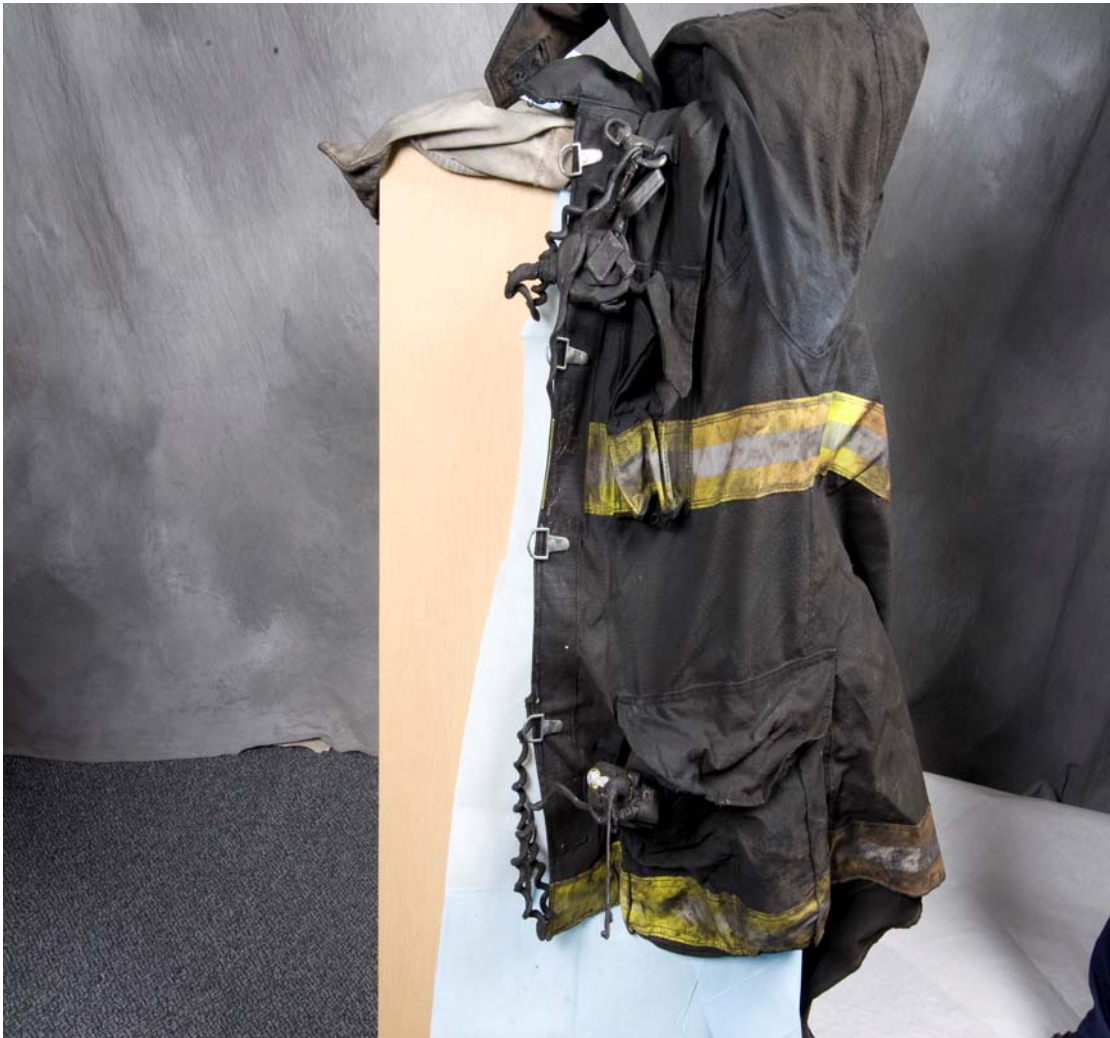
All members operating on the fireground were equipped with an 800 Mhz Fire Department issued portable radio. All Firefighter's radios were equipped with remote speaker/microphones. Victim 1 and 2's radios showed extreme heat damage.

Victim 1 had a portable radio located in the large lower left coat pocket with the remote speaker/microphone running along the outside of the coat to the collar area.

Victim 1's remote speaker/microphone failed due to high heat/fire, causing constant transmit condition. This disabled the radio from transmitting or receiving after 60 seconds.
