SAN FRANCISCO FIRE DEPARTMENT

**Safety Investigation Report
Line of Duty Deaths
133 Berkeley Way
June 2, 2011
Box 8155
Incident # 11050532**

February 2012

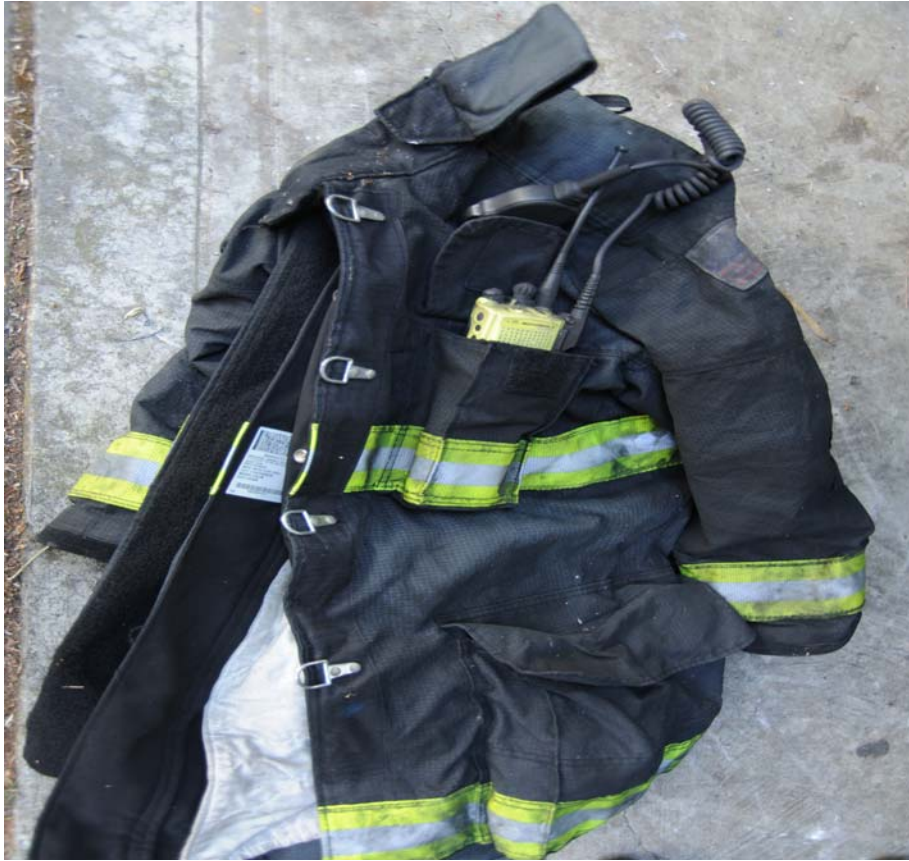
Engine 24 Officer had a portable radio located in the upper radio pocket on the left side of the coat with the remote speaker/microphone attached to the radio speaker/microphone tab on left side of coat.

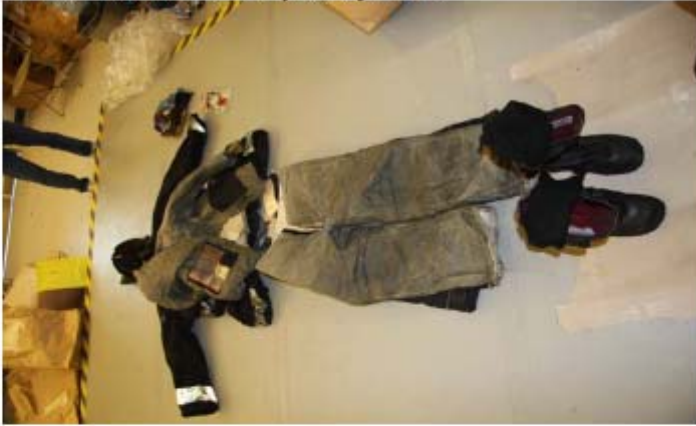
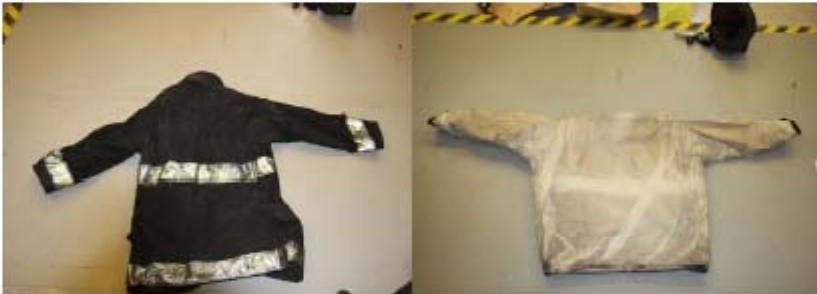
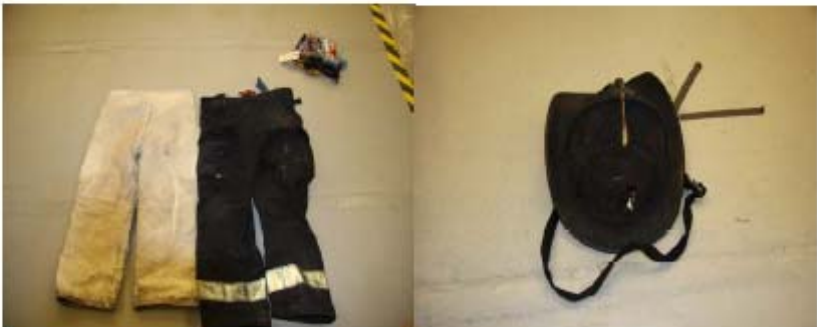
The turnout gear coat of Victim 1 showed dye sublimation from high levels of heat exposure, indicating extreme levels of heat exposure in those areas. The pants of Victim 1 and the coat and pants of Victim 2 do not indicate any dye sublimation. In both cases, although the heat may have been at severe emergency levels, the materials used in the gear did not reach extreme temperatures to have destroyed the fabrics. The degradation temperature of the high heat and flame resistant fibers used in the various outer shells of the garment are approximately 800°F to 1000°F for the Fusion (Nomex and Kevlar) outer shell and 1000°F-1200°F for the PBI Matrix (PBI and Kevlar) outer shell.

Victim 2 Gear Reviewed. Additional photos of gear on file.

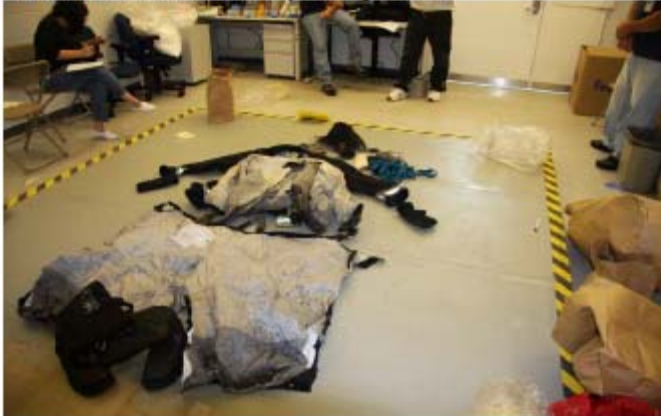
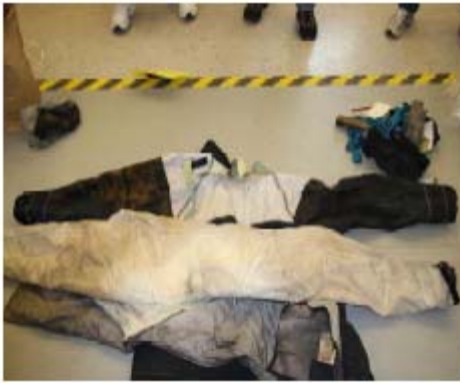
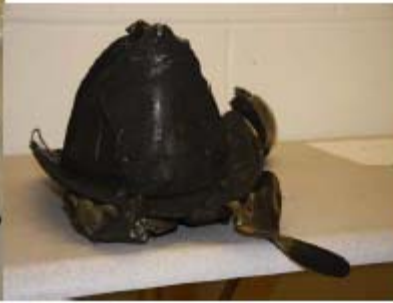
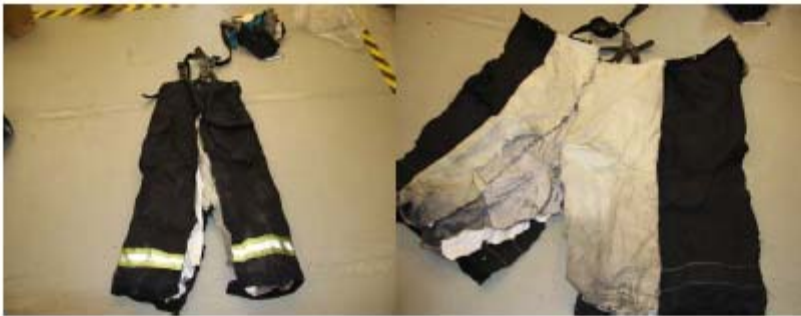
Victim 1 Gear Reviewed. Additional photos of gear on file

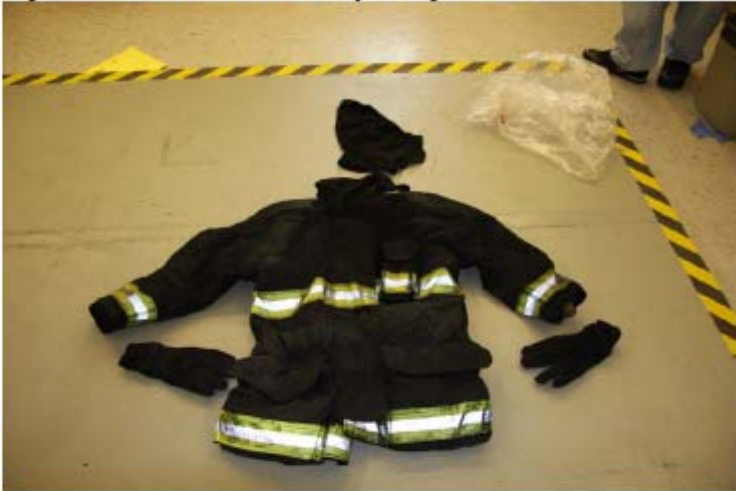
Engine 24 Officer Gear Reviewed. Additional photos of gear on file.

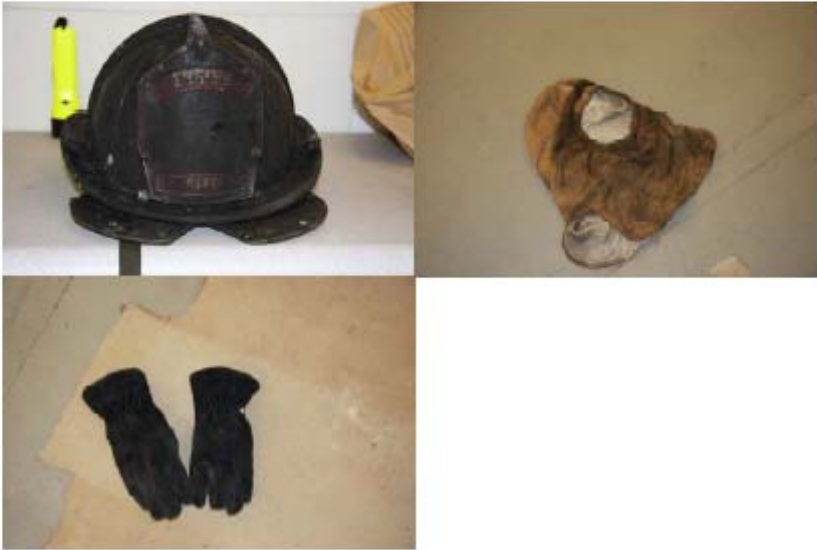
Firefighter Engine 11 Gear Reviewed. Additional photos of gear on file.
